Historical Affairs and Landmark Review Board

HALRB Meeting May 21, 2025, CoA 25-02

4102 N. Glebe Rd.: Request to repair the chapel's roof area that is damaged and replace with PVC and to repair a wood side door.

Walker Chapel United Methodist Church Exterior Restoration

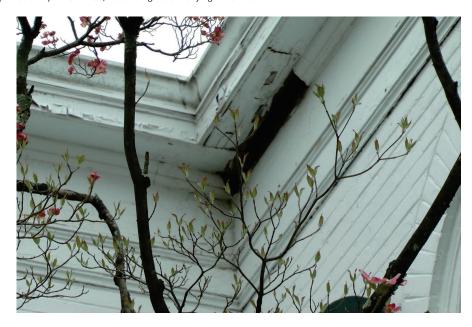
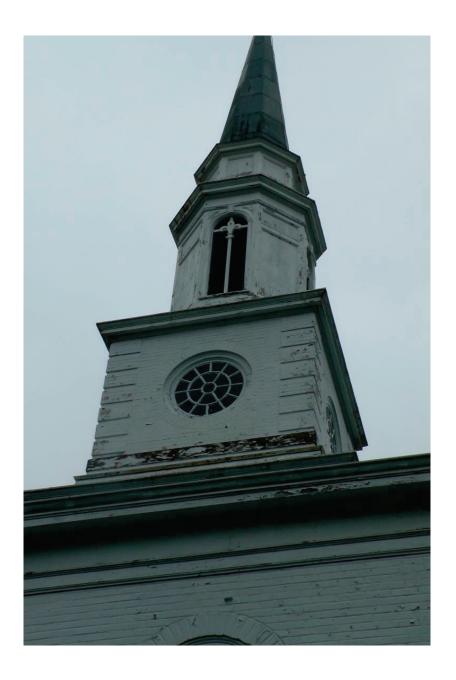
Rotted wood is visible high up on the fascia, portico gable, and steeple. As we scrape off the old loose paint, we suspect more will be found. Once found, the repair must occur quickly so exposed areas are not open to the weather. We also must do the bulk of the exterior work between June 15th and August 25th while the preschool children are away. We cannot expose them to debris and paint fumes.

Much of the trim on the Chapel consists of dense 1960s wood, in contrast to the soft pine currently available. We aim to preserve all wood surfaces unless they are rotted beyond restoration. The trim on the building is a common style with some composites of multiple pieces and appears to be recoverable. The rot seems mostly in the boards under the gutters. We would like to use look-alike PCV trim and boards where replacement is necessary. All surfaces will be primed and painted twice, thus hiding the underlying materials.

Replacement of rotted wood with look-alike PCV
