# GULF BRANCH OUTFALL REPAIR

N Nelson St Outfall  
Fall 2025 Engagement

# Outfall Area Current Conditions, Goals & Considerations

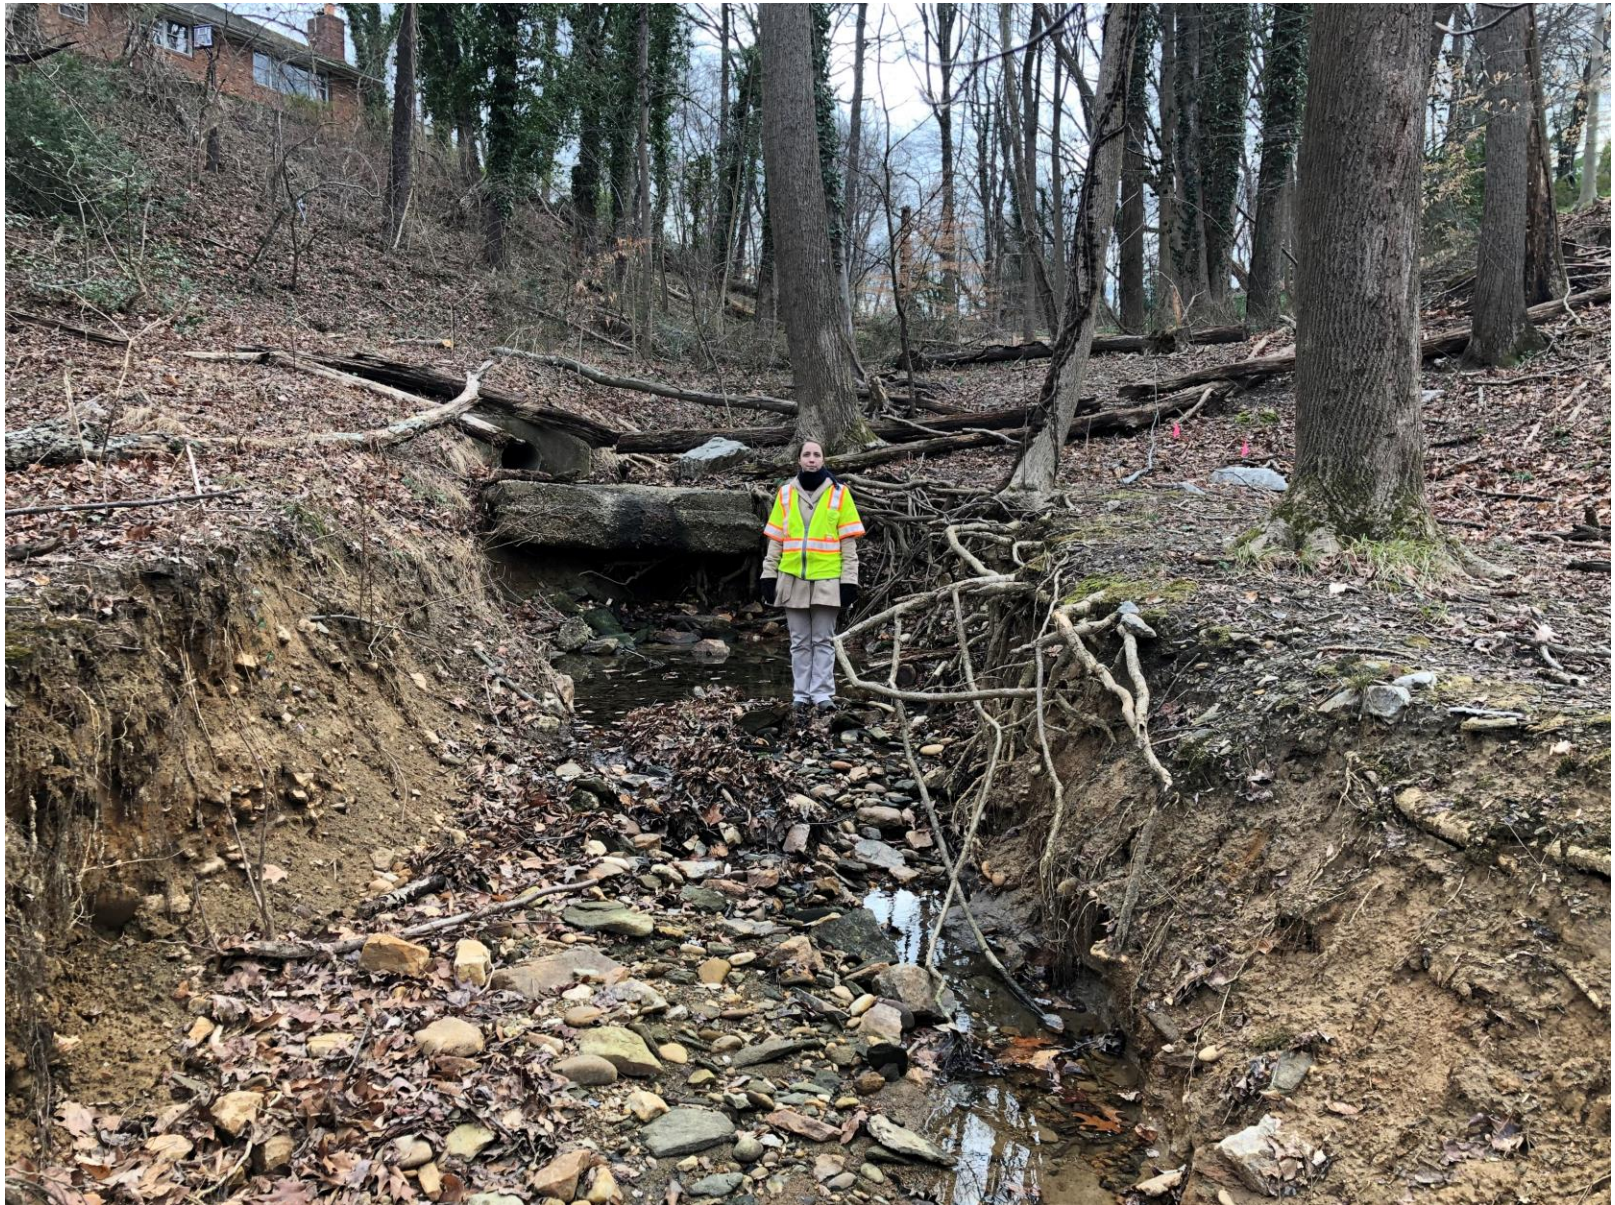
January 2020 Erosion undermining endwall and concrete pad

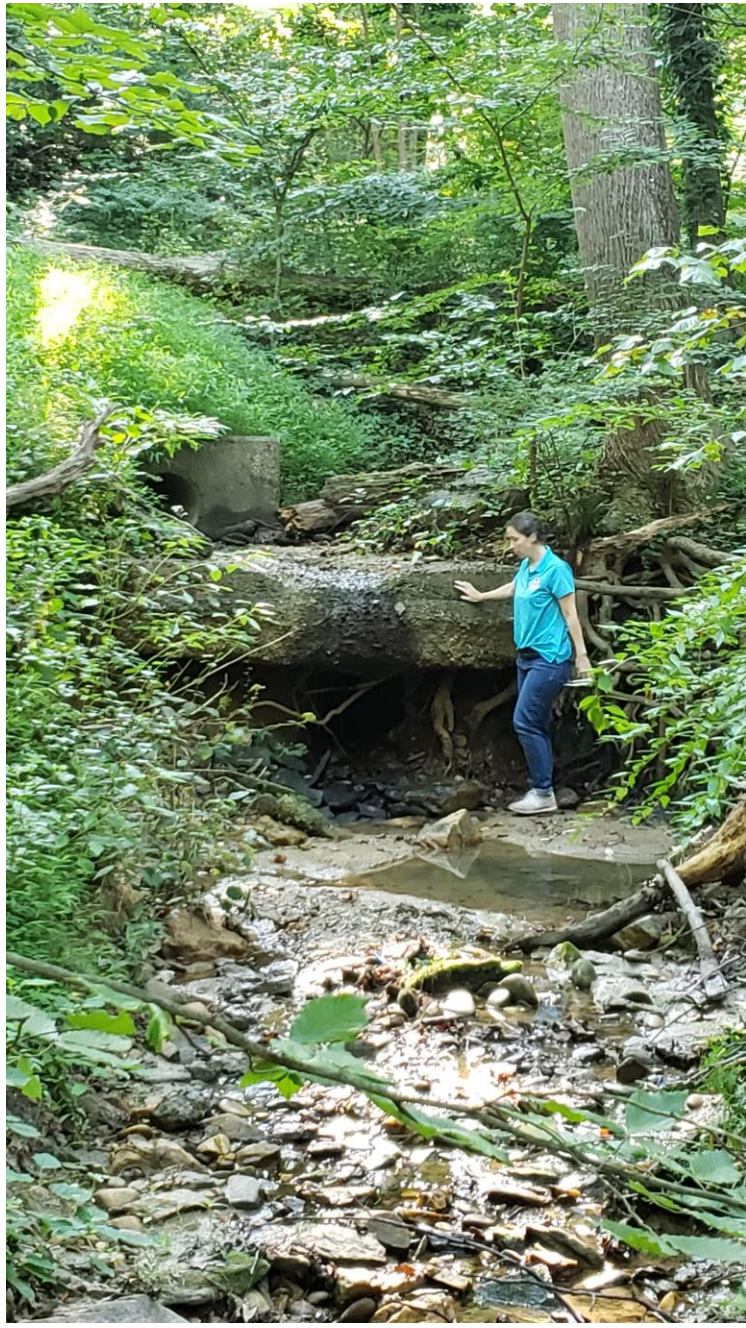
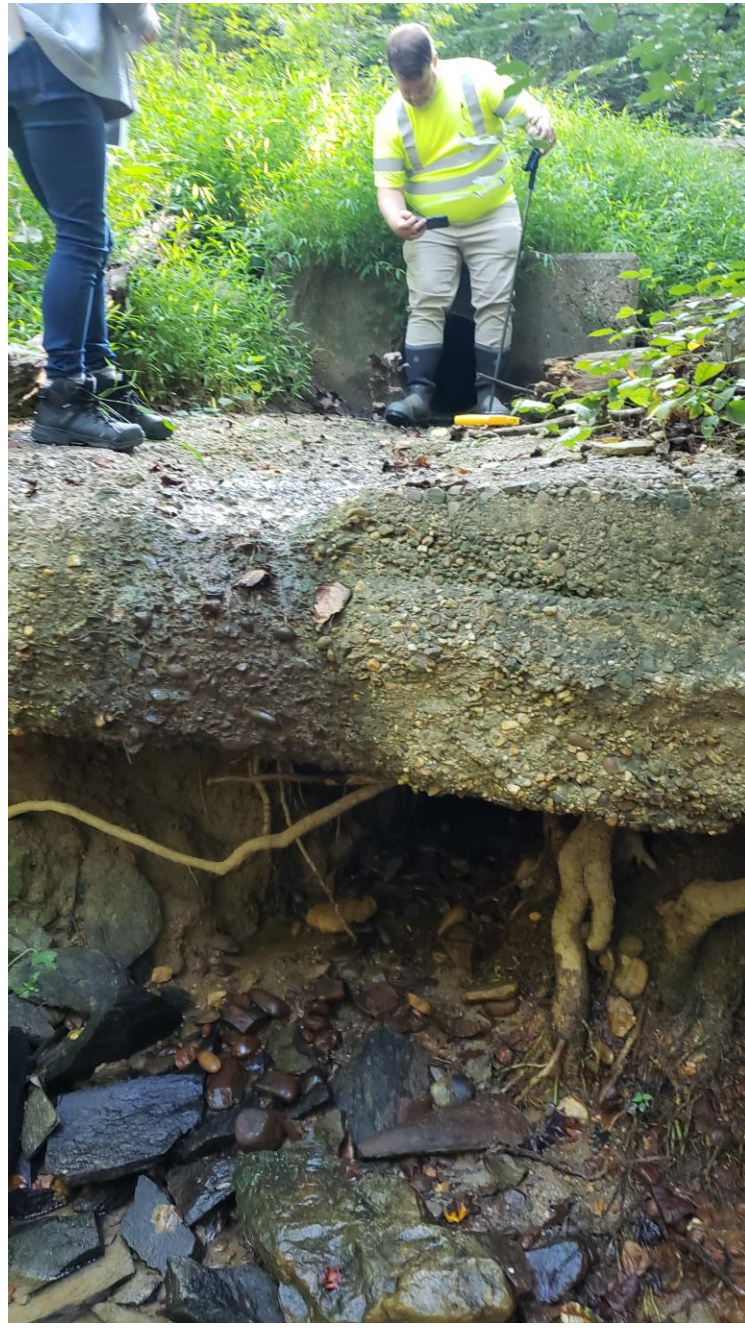
August 2025 Continued erosion under concrete pad

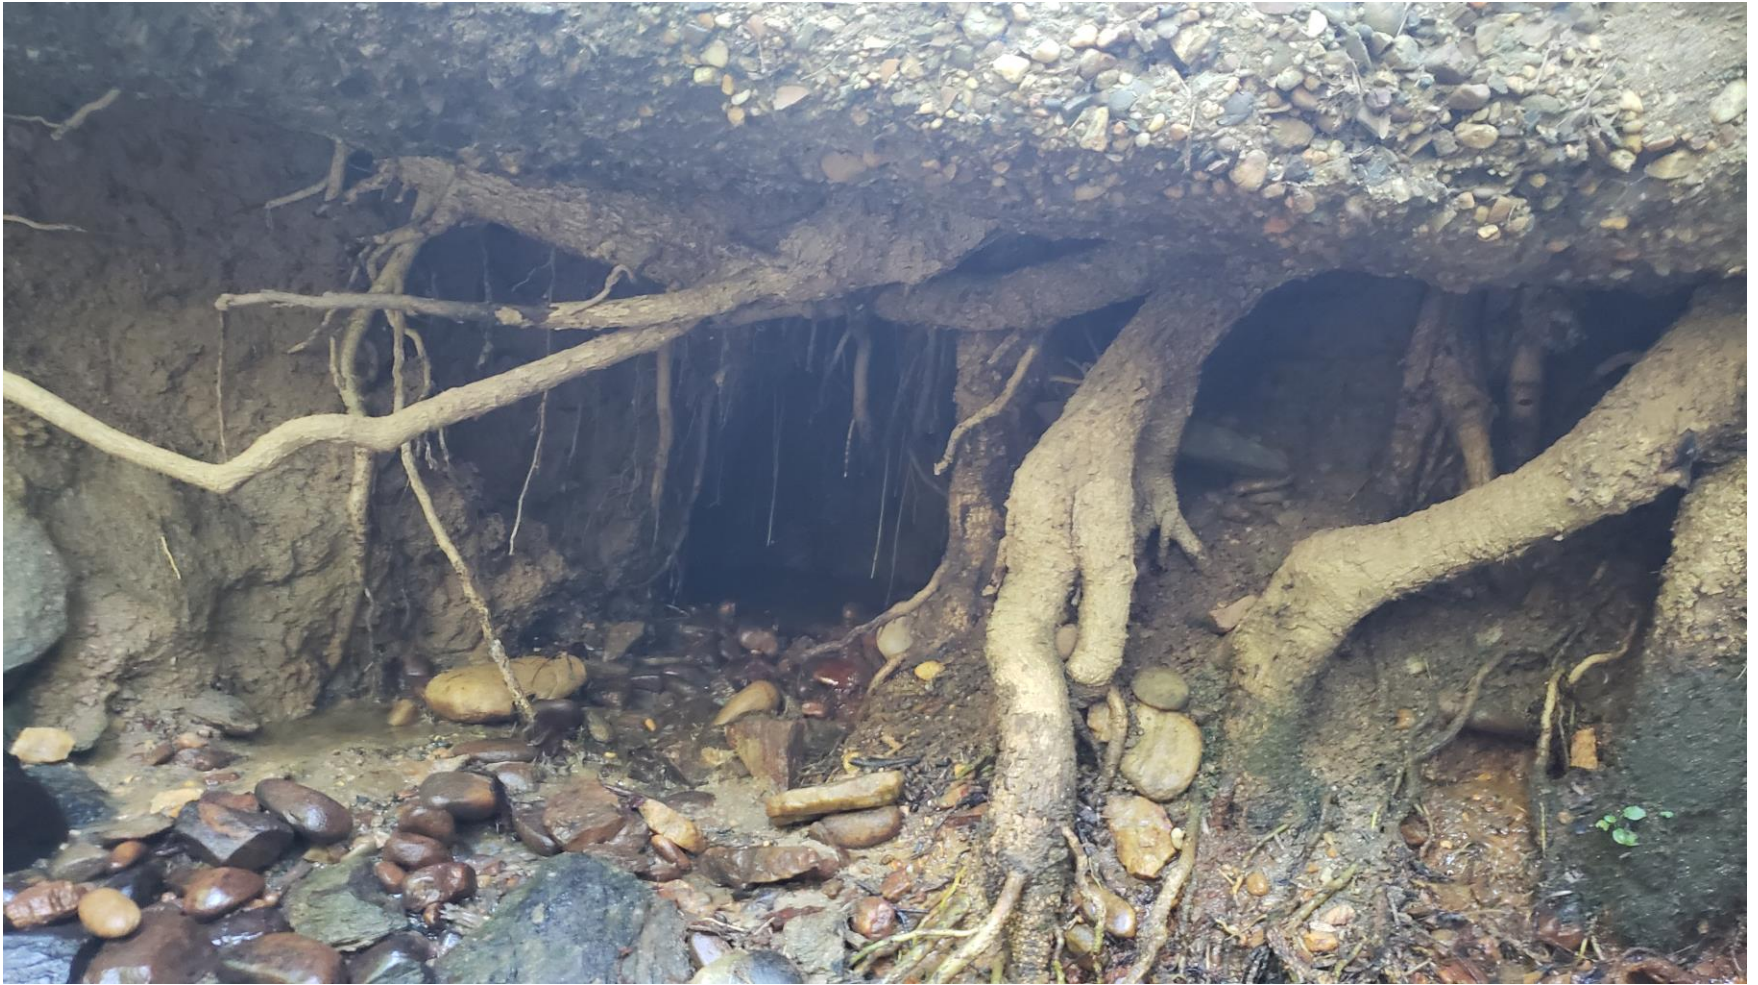
August 2025: Water drips through a hole in the concrete pad, continuing to undermine the structure.

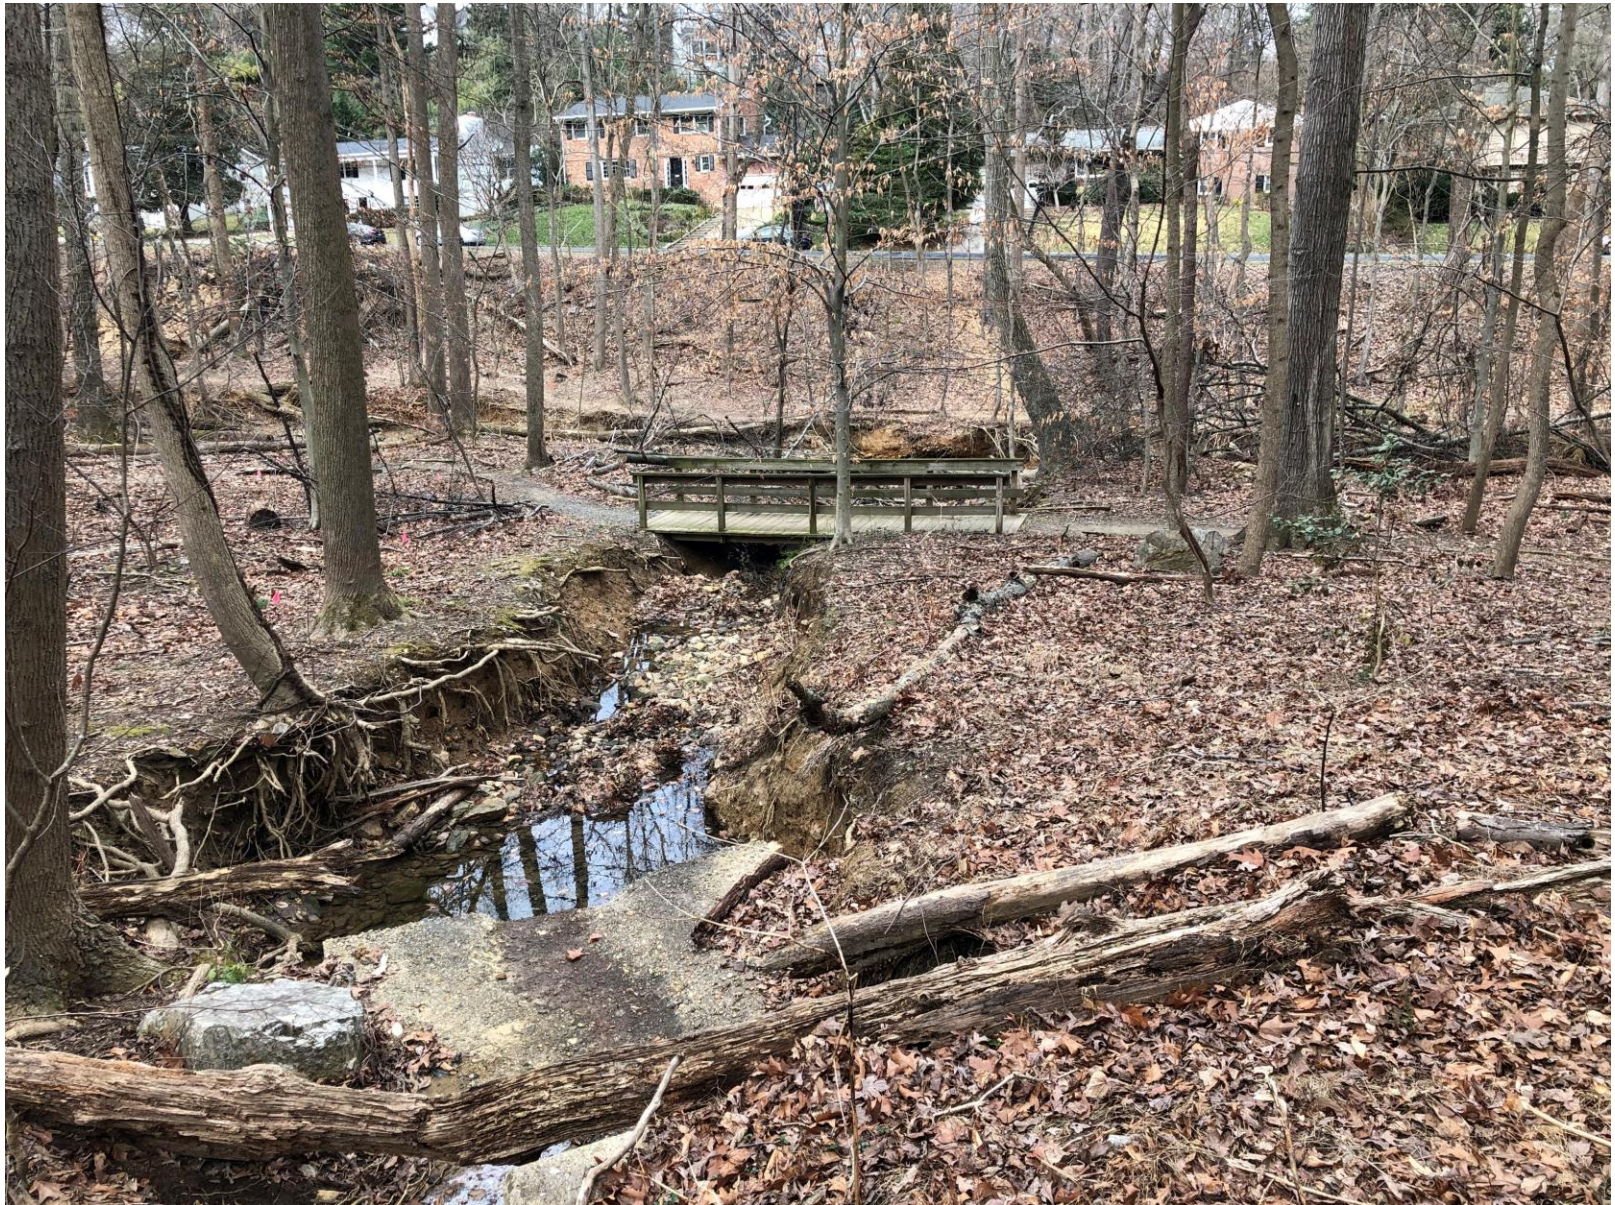
January 2020, View from upslope of the outfall toward Gulf Branch stream and 36<sup>th</sup> Rd N

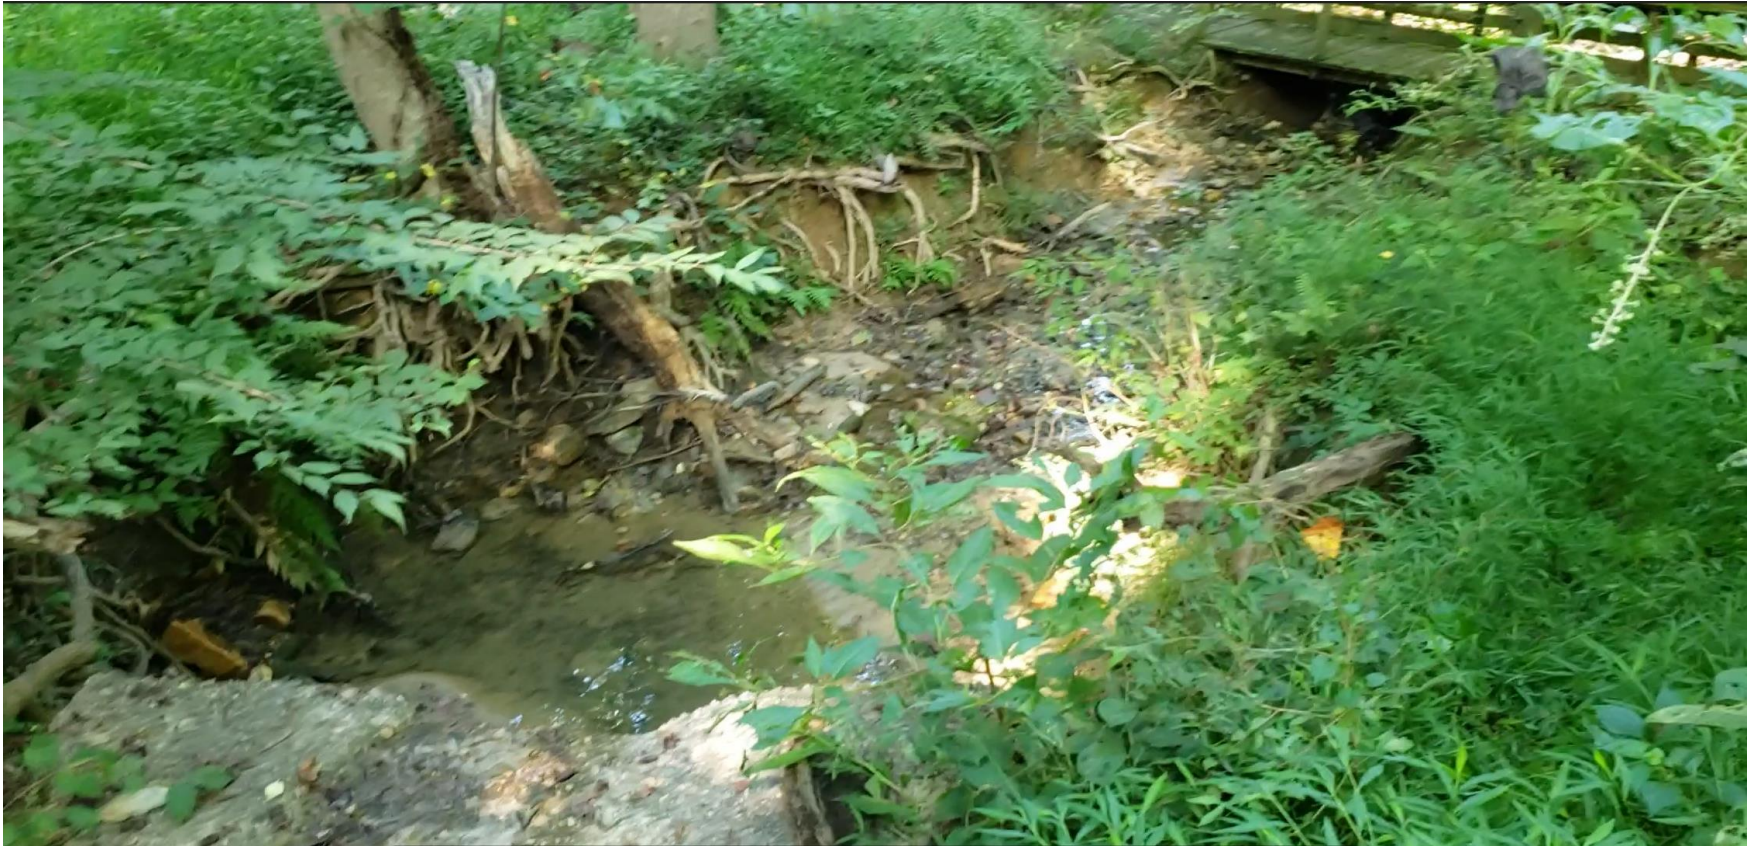
August 2025, View from upslope of the outfall toward Gulf Branch stream

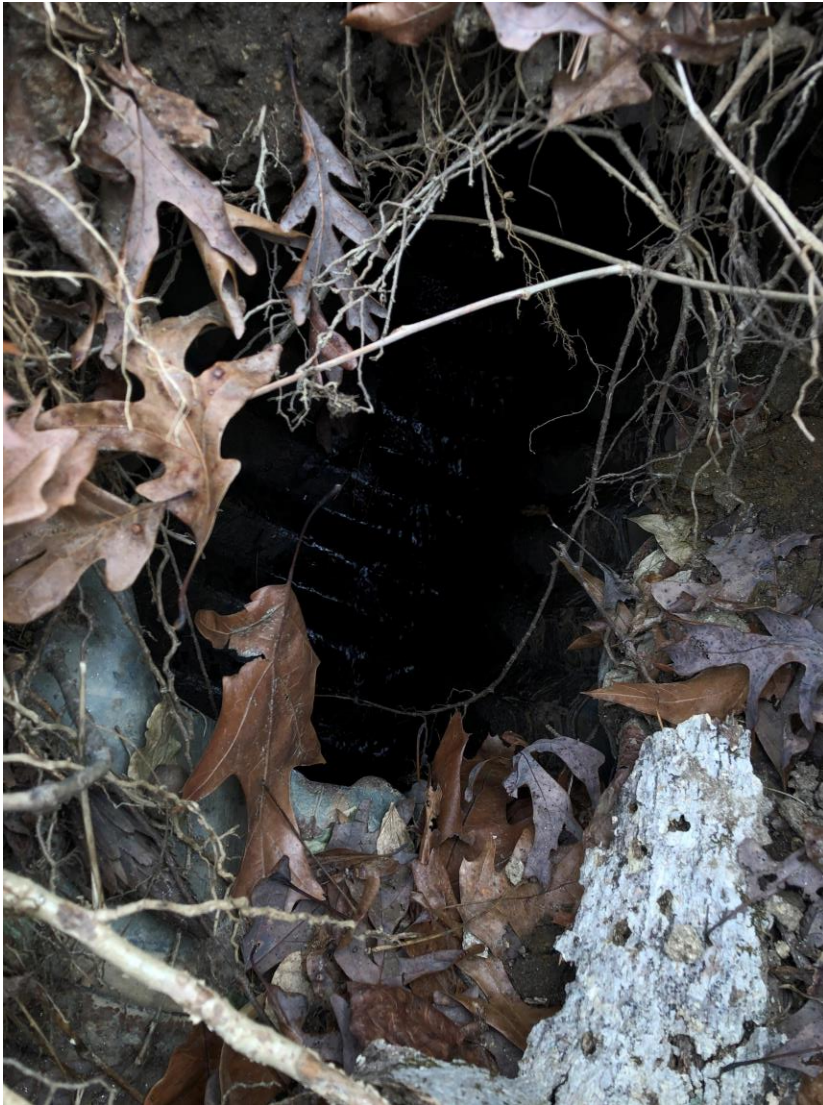
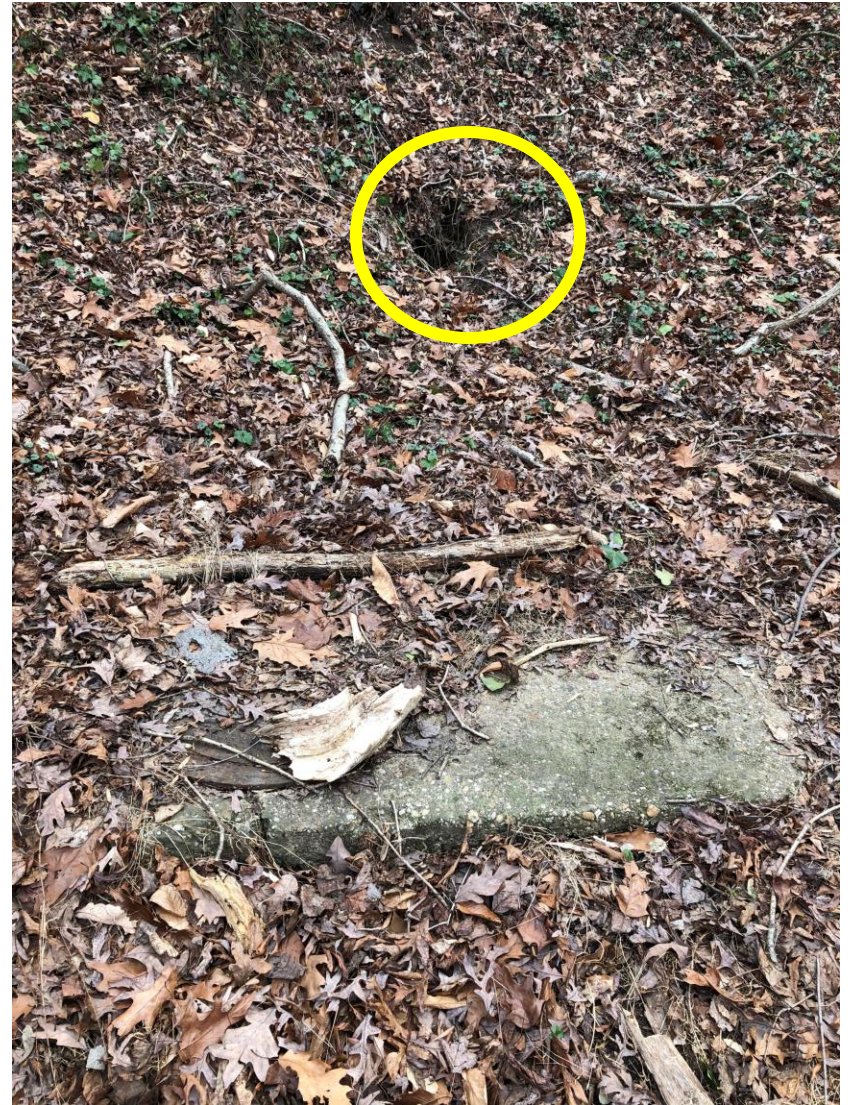
January 2020: Damaged storm pipe

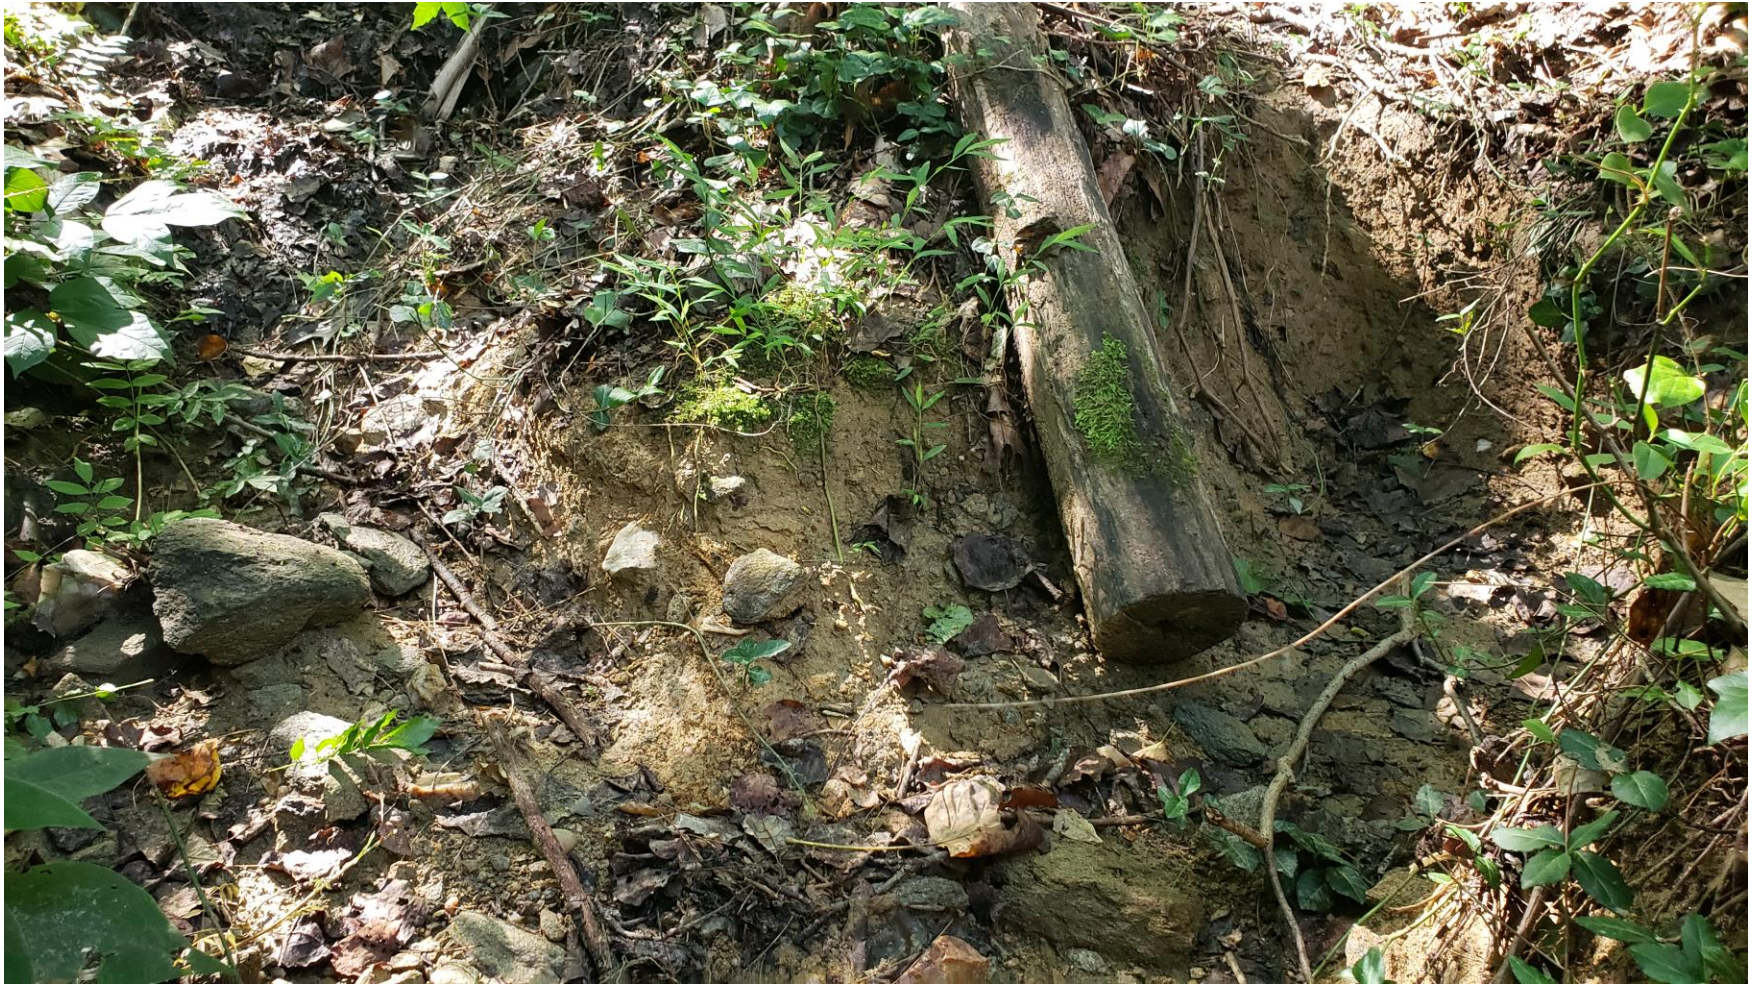
August 2025: Beginning of channel erosion

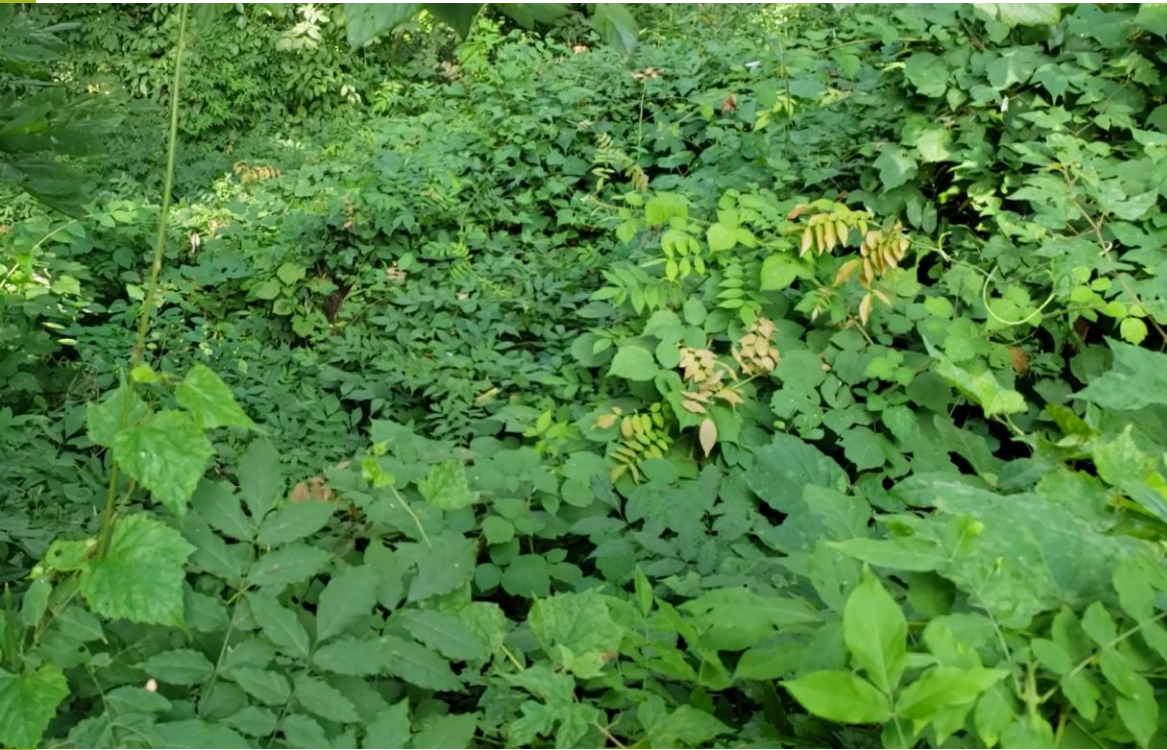
English Ivy, Porcelainberry and other vines in area

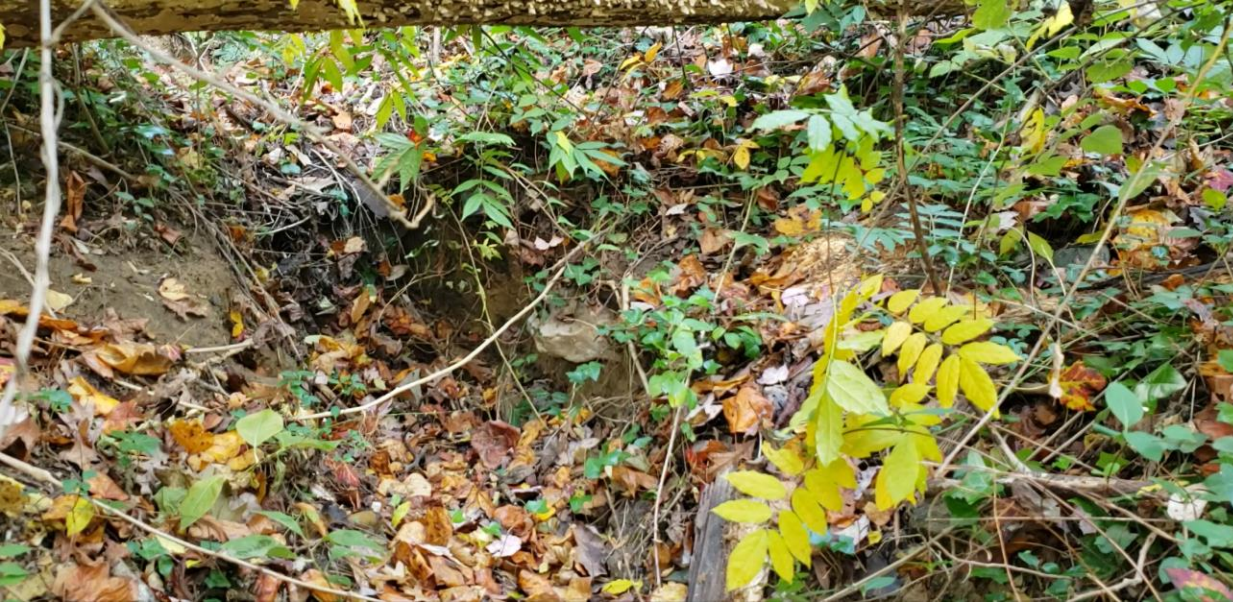
Channel cutting deeper  
just upslope of outfall  
structure (headcutting)
