WILSON BLVD & N QUINN ST

BEFORE TREATMENT

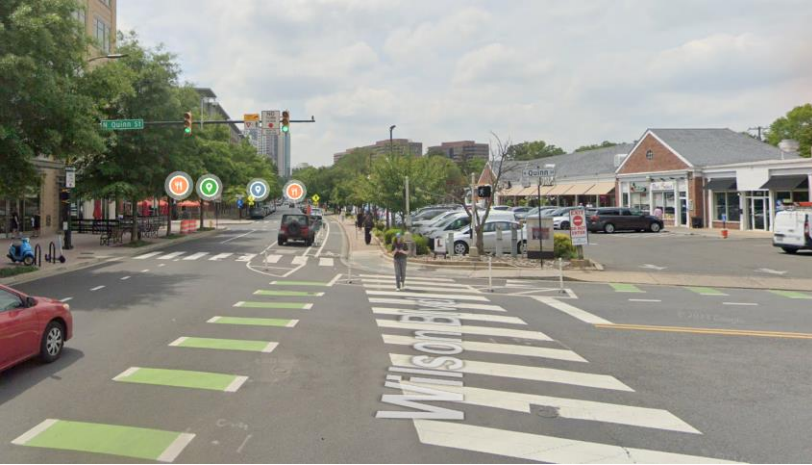
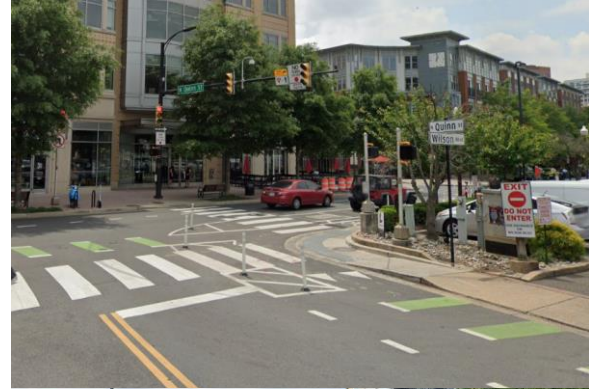
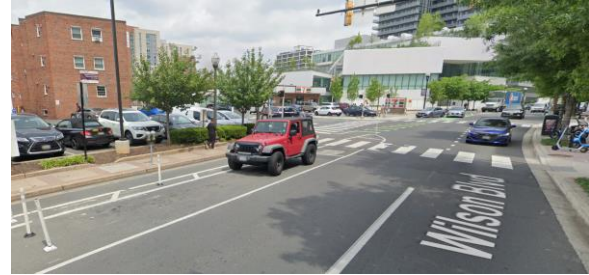
Safety Need: Identified through a project to resolve a drainage issue at the northeast corner of the intersection.

Project Description: This project installed a concrete valley gutter to improve stormwater drainage and provide new concrete islands to protect bike and pedestrians crossing at the northwest corner of the intersection where there is a protected bike lane connection.
