WILLIAMSBURG BLVD & 36TH ST N

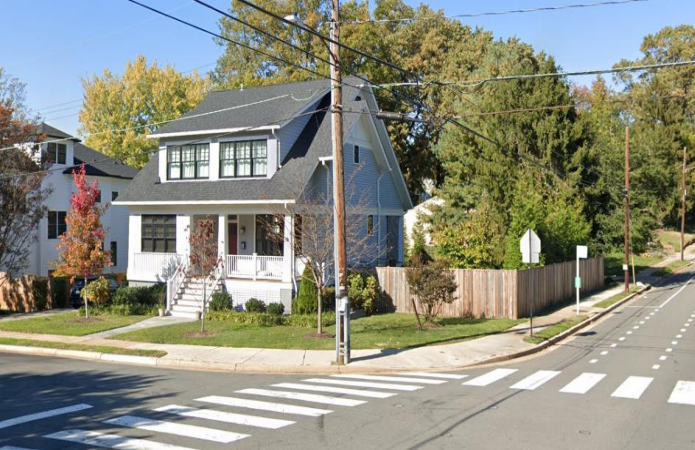
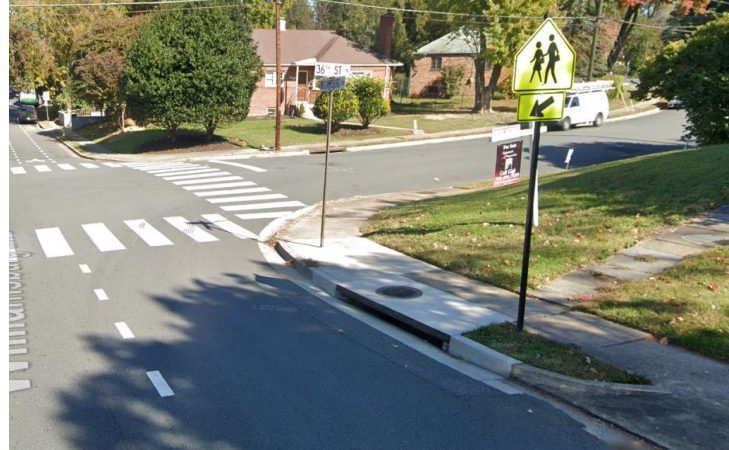
BEFORE TREATMENT

Safety Issue: Identified through the [school zone retrofits process](#)

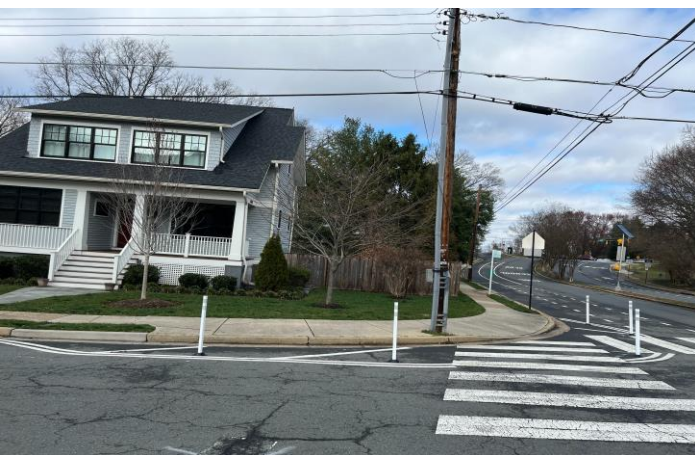
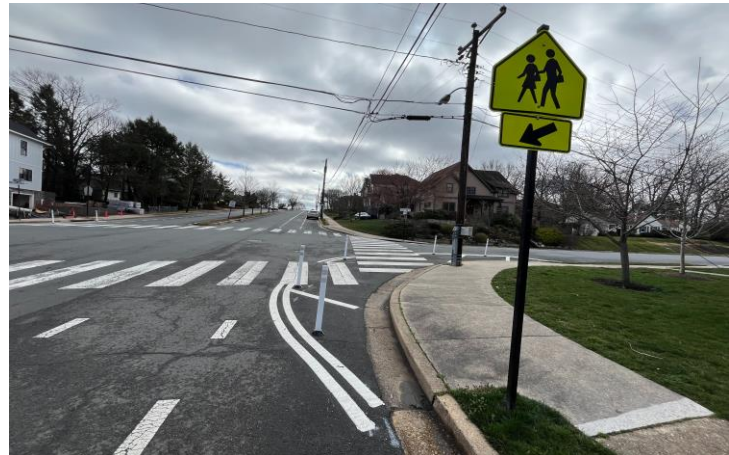
AFTER TREATMENT

Project Description: The project added tactical [curb extensions](#) (using markings and flex posts) to the northwest and southeast corners of the intersection, which shortened crossing distances for pedestrians and slowed vehicle turning speeds. It also added SLOW SCHOOL XING pavement markings in advance of the school zone crossing over arterial Williamsburg Blvd per the County's [school zone guidelines](#).
