S Walter Reed Dr & 12th St S

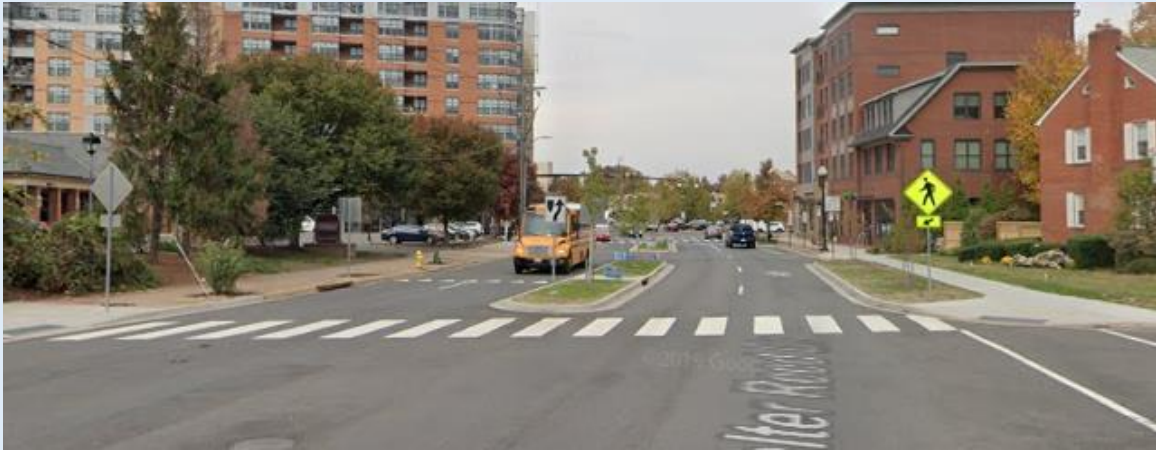
BEFORE TREATMENT

Safety Issue: Identified through a 2021 initial safety audit of the S Walter Reed Dr High-Injury Network corridor. Staff collected pedestrian and bike counts at various intersections along this stretch of S. Walter Reed Drive and identified the crosswalks with the highest volumes for RRFBs.

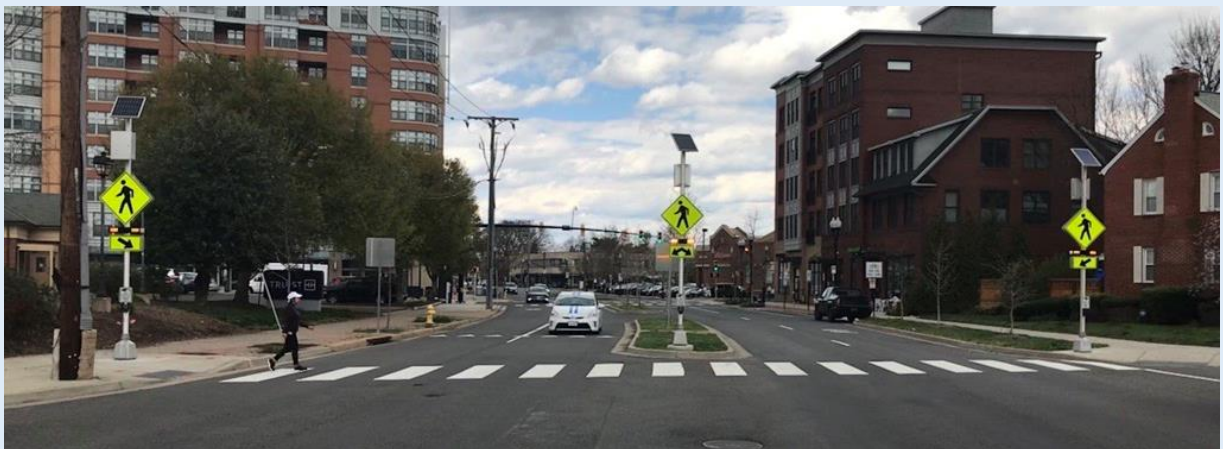
AFTER TREATMENT

Project Description: Rectangular rapid-flashing beacons (RRFBs) were installed on the northside crosswalk over S Walter Reed Dr at the intersection of 12th St S. The RRFBs will increase pedestrian and bike visibility and reduce multiple threat crashes (in other words, it helps to minimize crashes that occur when a vehicle that has stopped to let a pedestrian or bike cross blocks the view of the crosswalk from another on-coming vehicle).
