S Walter Reed Dr & 14th St S

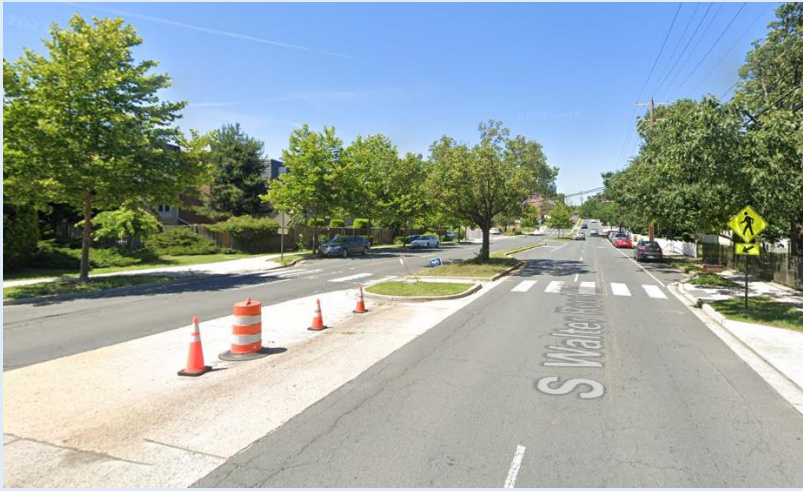
BEFORE TREATMENT

Safety Issue: Identified through a 2021 initial safety audit of the S Walter Reed Dr High-Injury Network corridor. Staff collected pedestrian and bike counts at various intersections along this stretch of S. Walter Reed Drive and identified the crosswalks with the highest volumes for RRFBs.

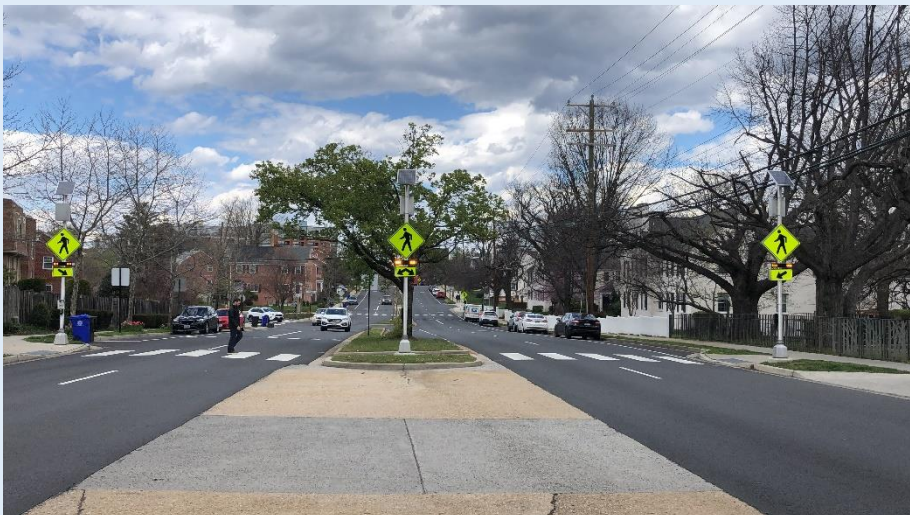
AFTER TREATMENT

Project Description: Rectangular rapid-flashing beacons (RRFBs) were installed on the northside crosswalk over S Walter Reed Dr at the intersection of 12th St S. The RRFBs will increase pedestrian and bike visibility and reduce multiple threat crashes (in other words, it helps to minimize crashes that occur when a vehicle that has stopped to let a pedestrian or bike cross blocks the view of the crosswalk from another on-coming vehicle).

Completed: Winter 2021/2022
