VISION ZERO

ARLINGTON COUNTY

VA-237 Corridor Progress Updates

Rather than conducting a second safety audit of the VA-237 corridor, this info-sheet evaluates the County's progress on the action items set forth in 2018 and identifies additional needs to enhance safety on the corridor.

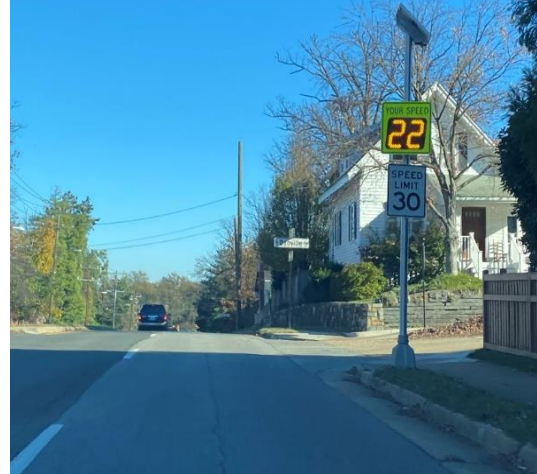
- ✓ Added enhanced pavement markings and [tactical safety improvements](#) at 3 intersections (2019)
- ✓ Improved sightlines by trimming vegetation approaching N Barton St from the west (2019)
- ✓ Installed speed feedback indicator. (2020)
Data indicate a 1mph reduction since installation
- ✓ Installed [rectangular rapid flashing beacons \(RRFBs\)](#) at 10th St N & N Irving St (2021)
- ⌚ Conducting speed study on 10th St N. (Anticipated 2023)

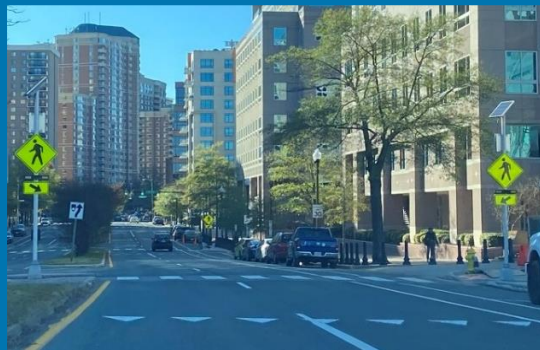
Constructing a [capital project](#) at Wilson/10th (Early design phases)

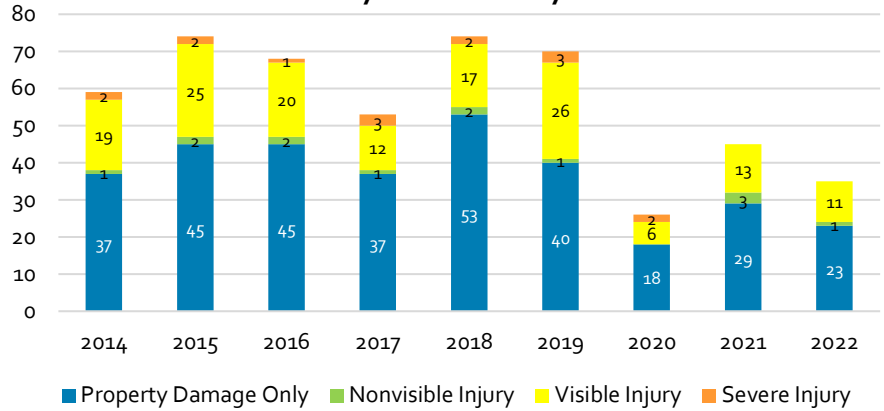
Severity of Crashes by Year

The average annual number of crashes on this corridor was 66 crashes from 2014-2018 (2 severe, 7 pedestrian, 2 bike) and then 44 crashes from 2019-2022 (1 severe, 5 pedestrian, 2 bike). We will continue to monitor crashes, considering potential variance in traffic patterns due to the pandemic. The maps below show crashes before and after the 2018 acquisition and highlights recent improvements.
