BARCROFT APARTMENTS PHASE RBU2 REHABILITATION

SECTION 1 BUILDINGS 1-11

HALRB SUBMISSION #2

APRIL 16, 2025

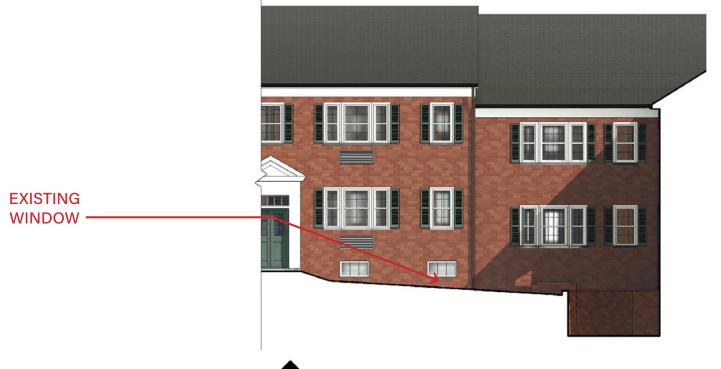
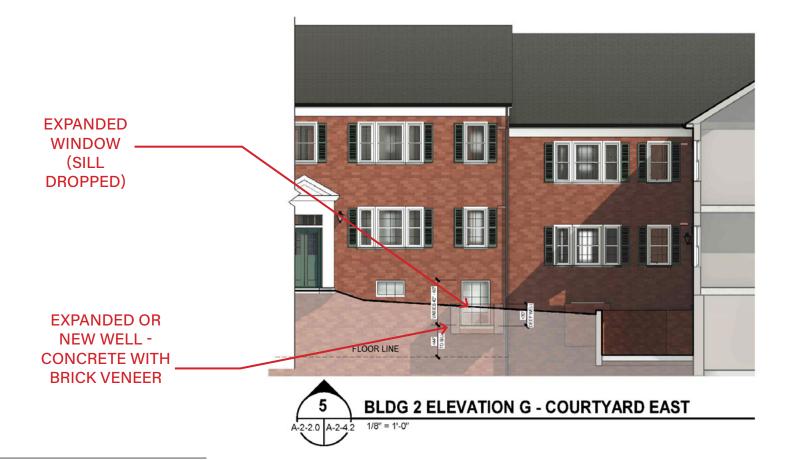
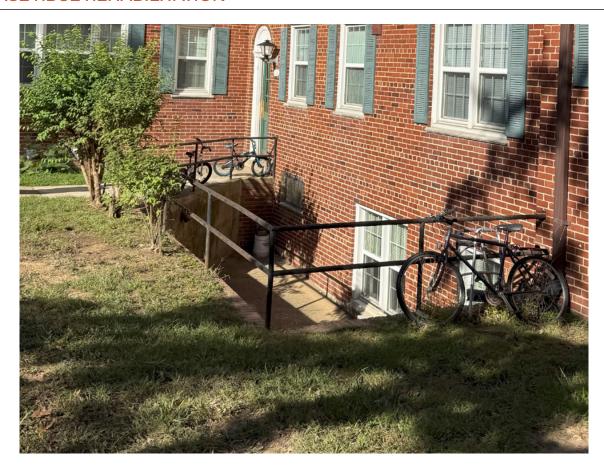
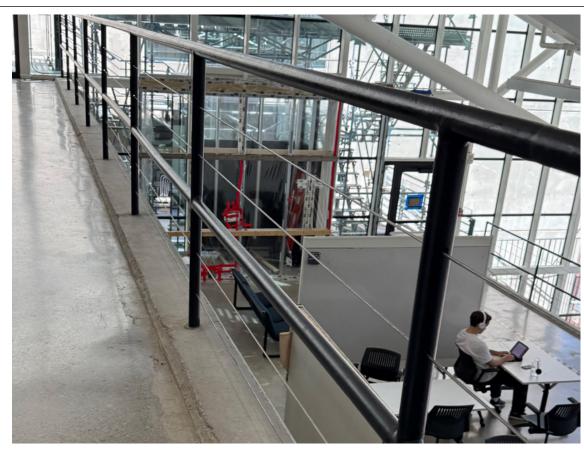
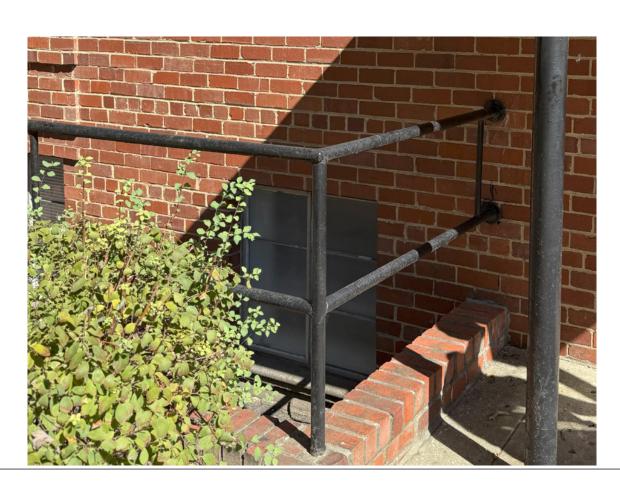
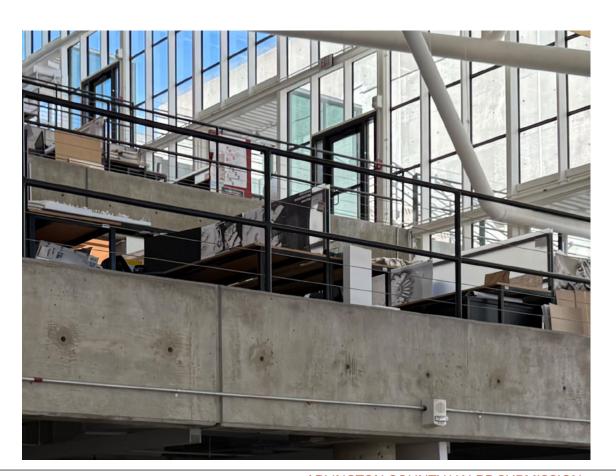
BARCROFT PHASE RBU2 REHABILITATION EGRESS WINDOW EXTENSION STRATEGY

- Expanding select existing basement windows and areaways to meet egress requirements for new family sized units.
- * Conservation Area standard modification necessary in order to meet MDCR requirements.
