WALKER CHAPEL

United Methodist Church

Exterior Restoration

2025

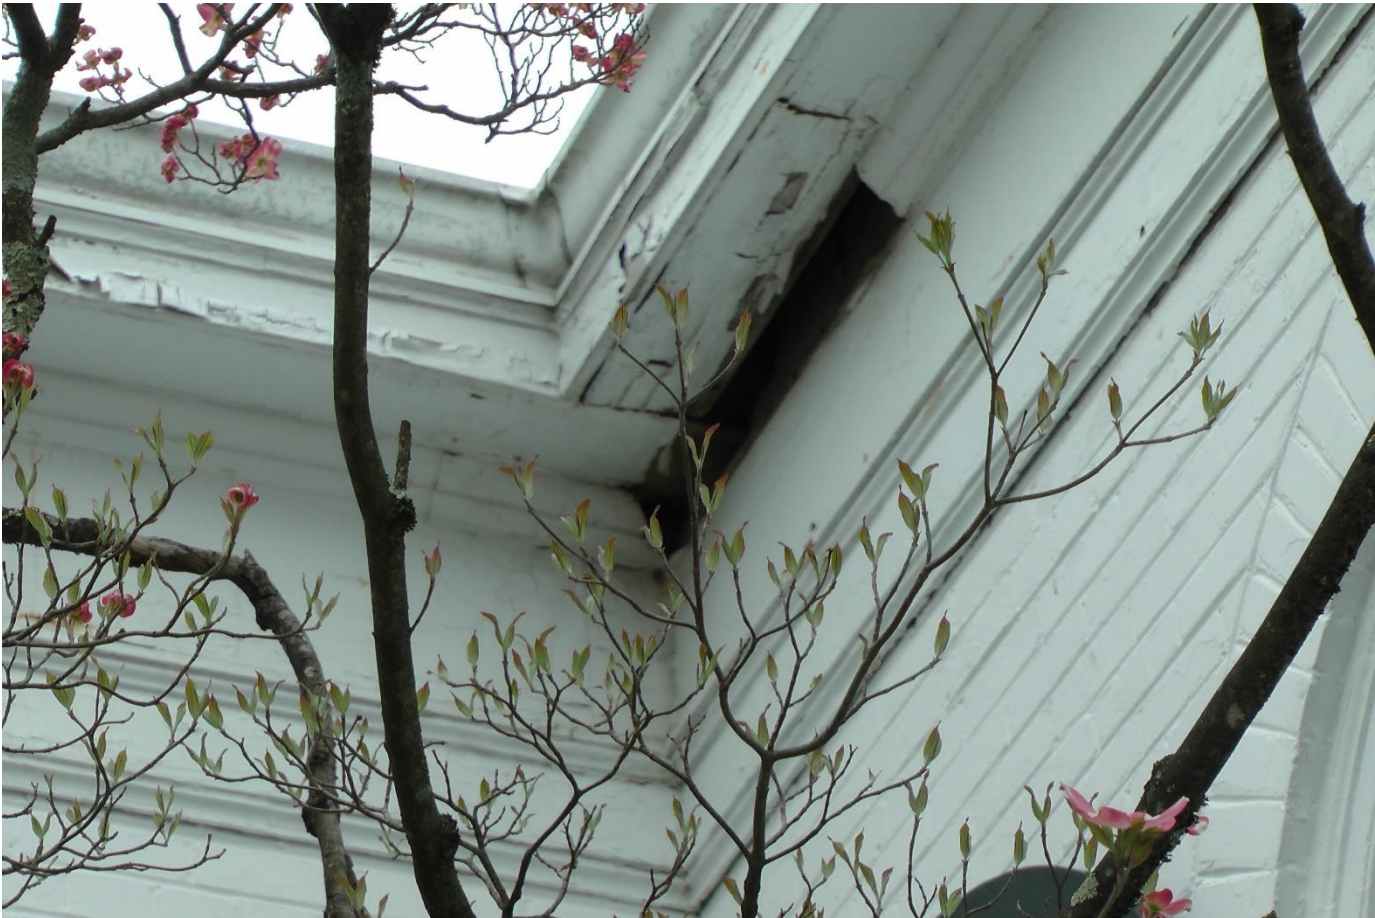
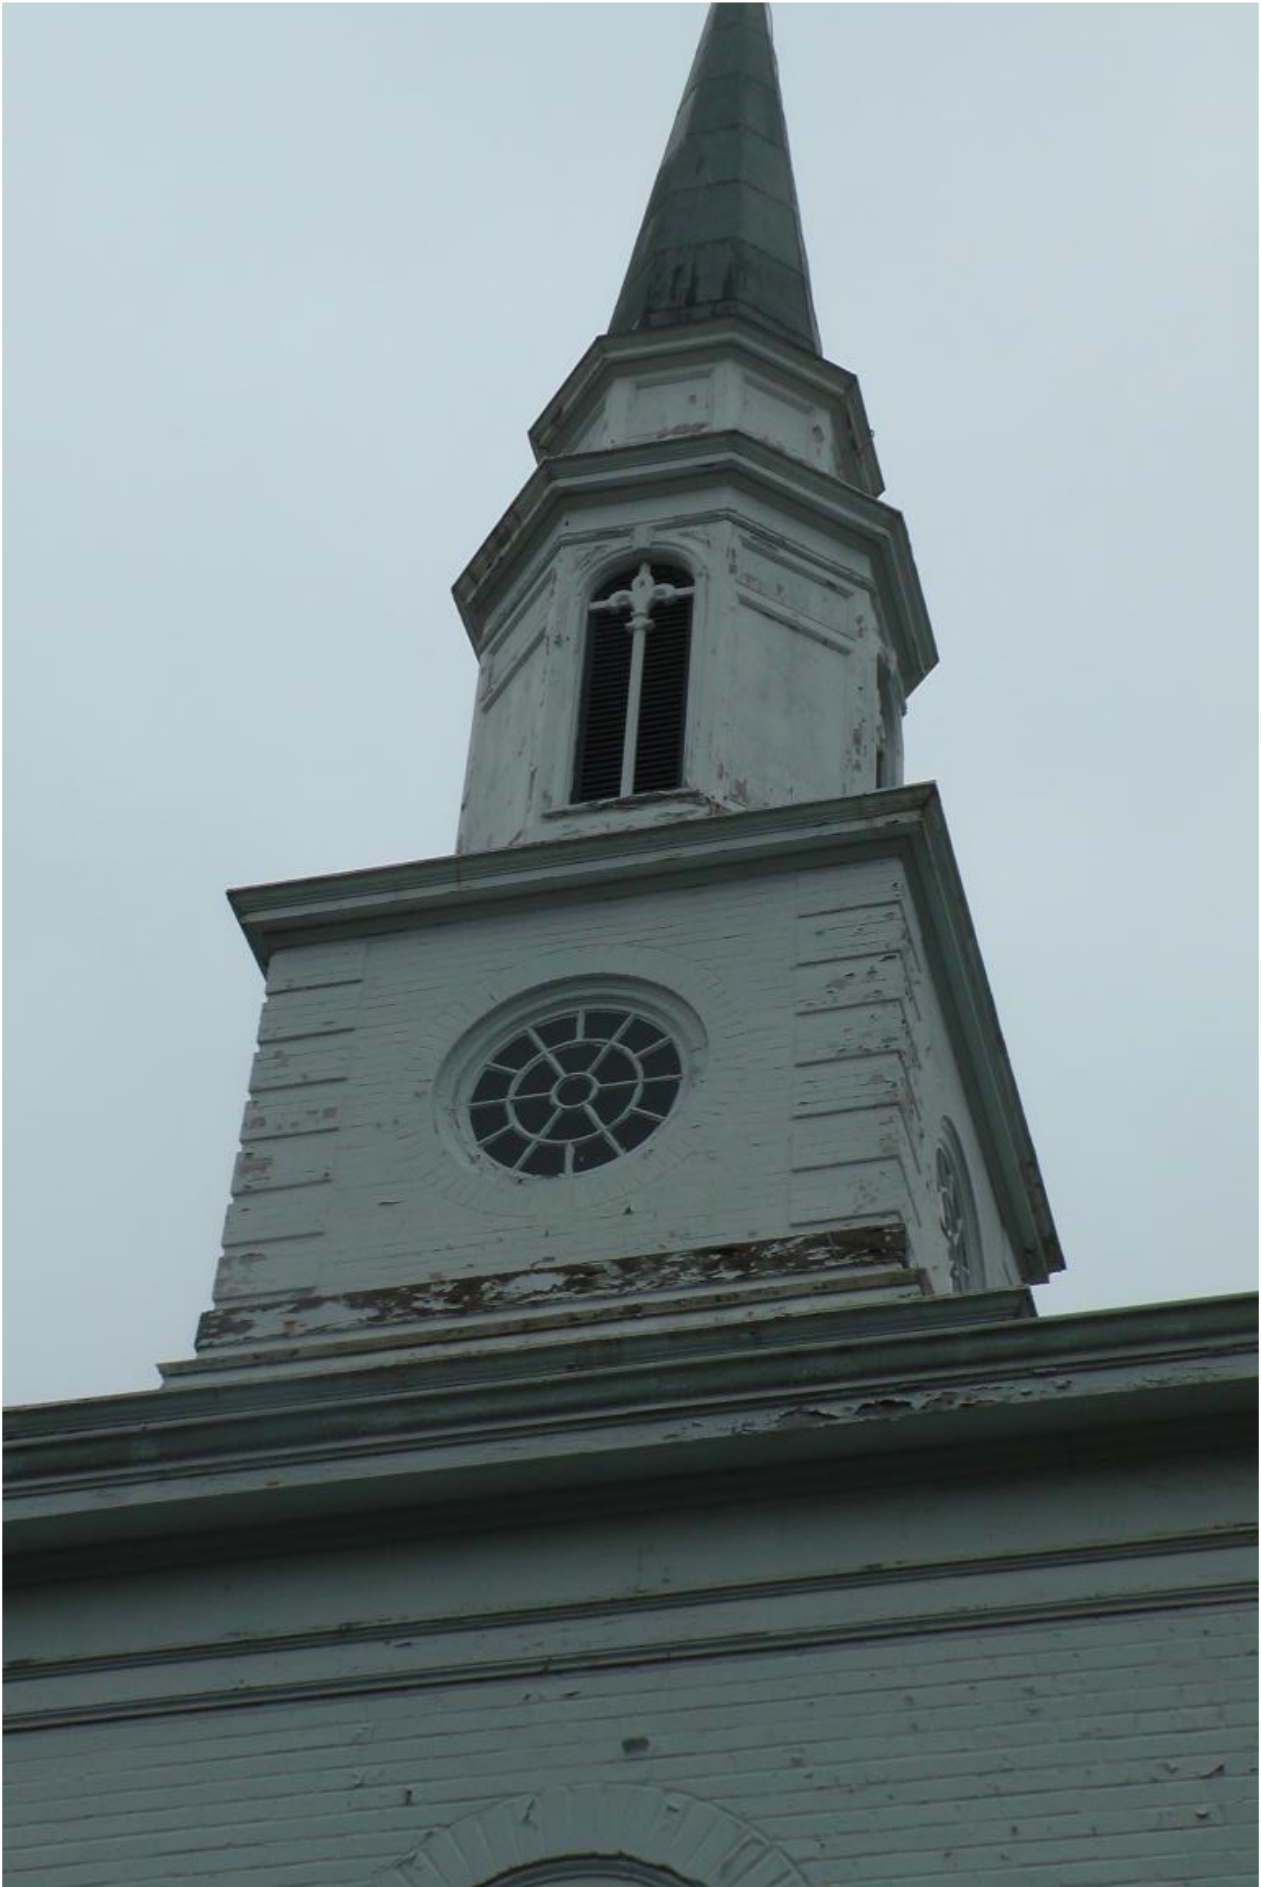
Rotted wood is visible high up on the fascia, portico gable, and steeple. As we scrape off the old loose paint, we suspect more will be found. Once found, the repair must occur quickly so exposed areas are not open to the weather. We also must do the bulk of the exterior work between June 15th and August 25th while the preschool children are away. We cannot expose them to debris and paint fumes.

Much of the trim on the Chapel consists of dense 1960s wood, in contrast to the soft pine currently available. We aim to preserve all wood surfaces unless they are rotted beyond restoration. The trim on the building is a common style with some composites of multiple pieces and appears to be recoverable. The rot seems mostly in the boards under the gutters. We would like to use look-alike PCV trim and boards where replacement is necessary. All surfaces will be primed and painted twice, thus hiding the underlying materials.

Replacement of rotted wood with look-alike PCV

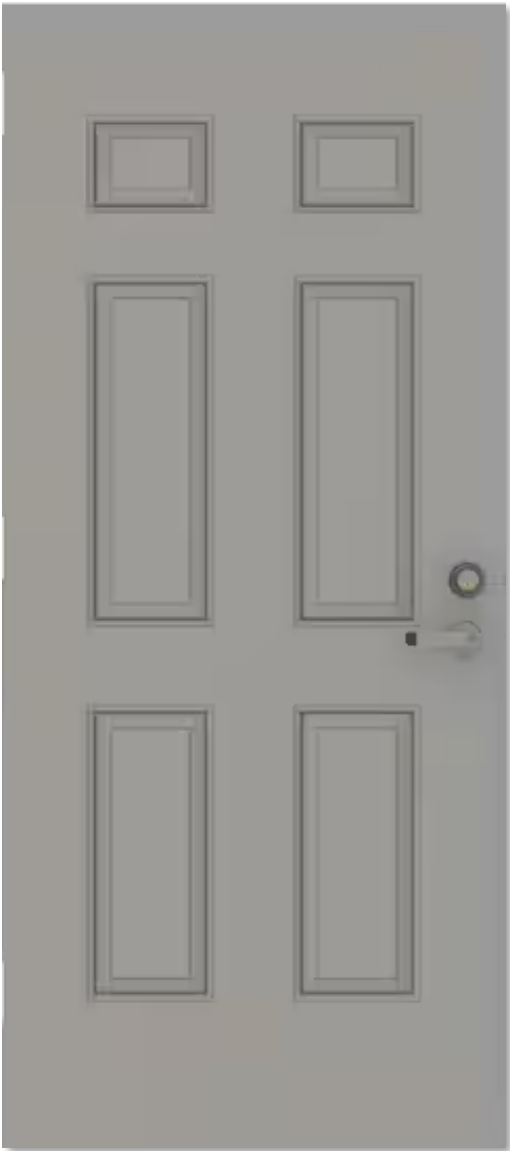
This is a 36 " x 80” door slab, a heavy-duty steel 6-panel security unit.

It has a 90-minute fire and smoke label and is manufactured with high-quality Galvanized steel. Even though it looks like raw steel, it is not. The Priming process is done at the Steel Mill when the steel is manufactured.

The door will have a push-bar exit and ball-bearing, spring-loaded hinges for easy exit and self-closing.

It will be painted to match the Chapel exterior.

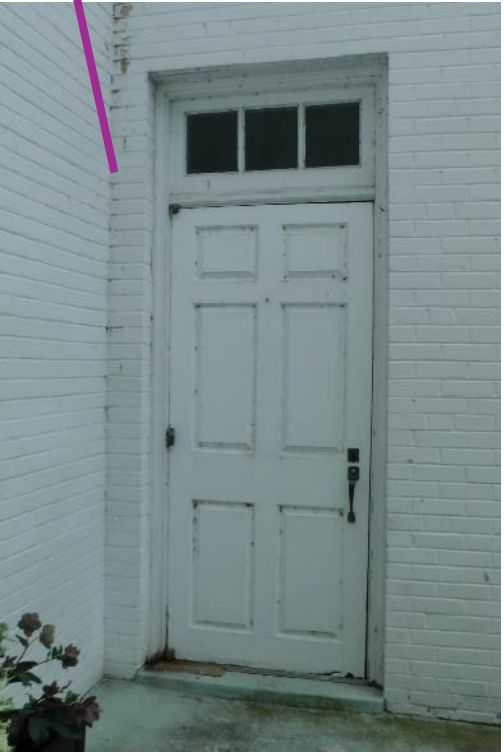
The fire exit door from the Sanctuary to the outside office landing is tucked behind the elevator used by elderly and handicapped parishioners on Sunday to get to the Sanctuary level of the church. It is a heavy wooden door in bad shape and hard to open. Due to the angle of the church, the door is not visible to passing motorists on Glebe Road. We want to replace it with a commercial six-panel steel door with a push-bar exit and ball-bearing hinges. The main office entry on the landing is a similar double steel door. This change would thus additionally make the two doors look the same. We will retain the transom window.

Side Door to be replaced

Replacement Door Slab
