Wilson Blvd Safety Audit

Department of Environmental Services
Transportation Engineering & Operations
N Arlington Ridge Rd to N Randolph St

Audit: July 2024

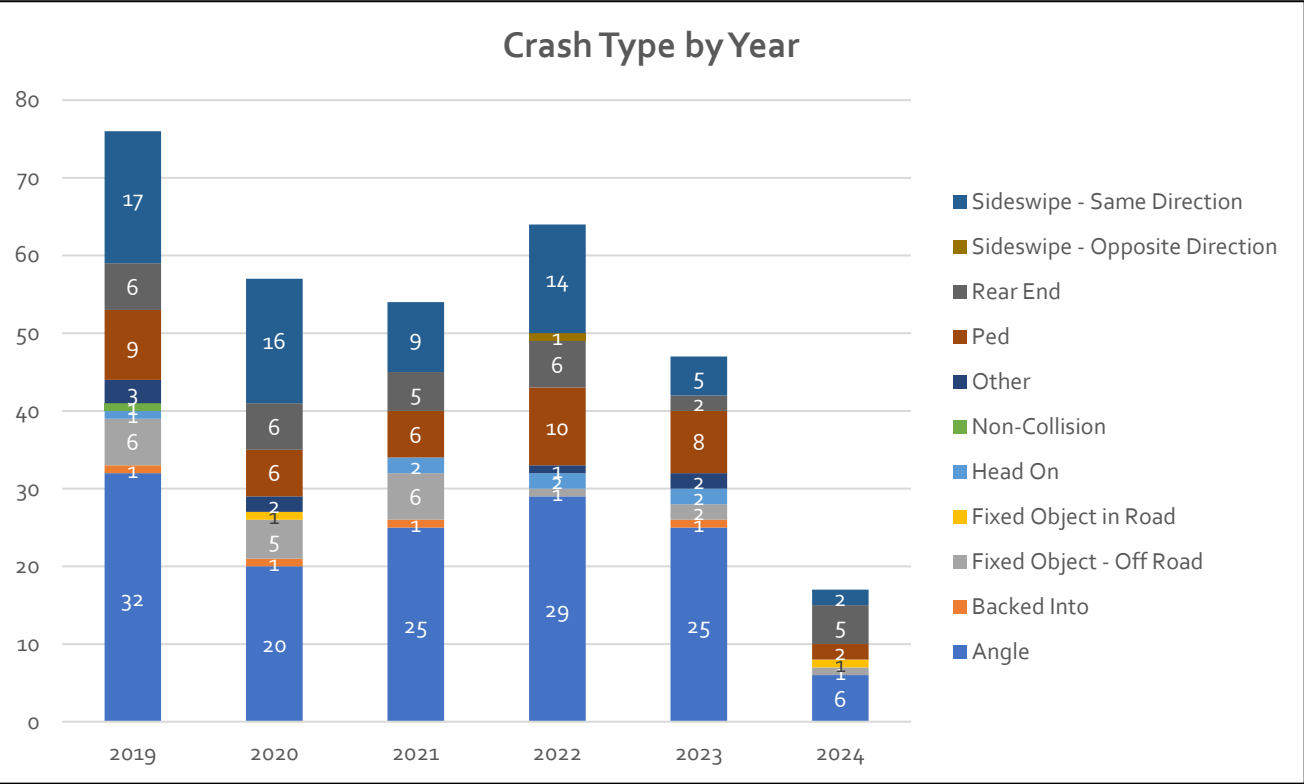
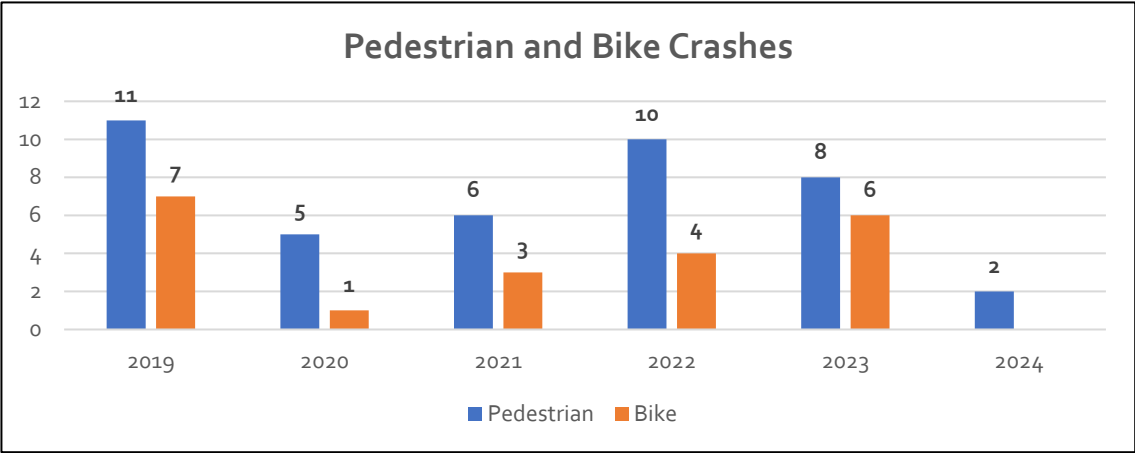
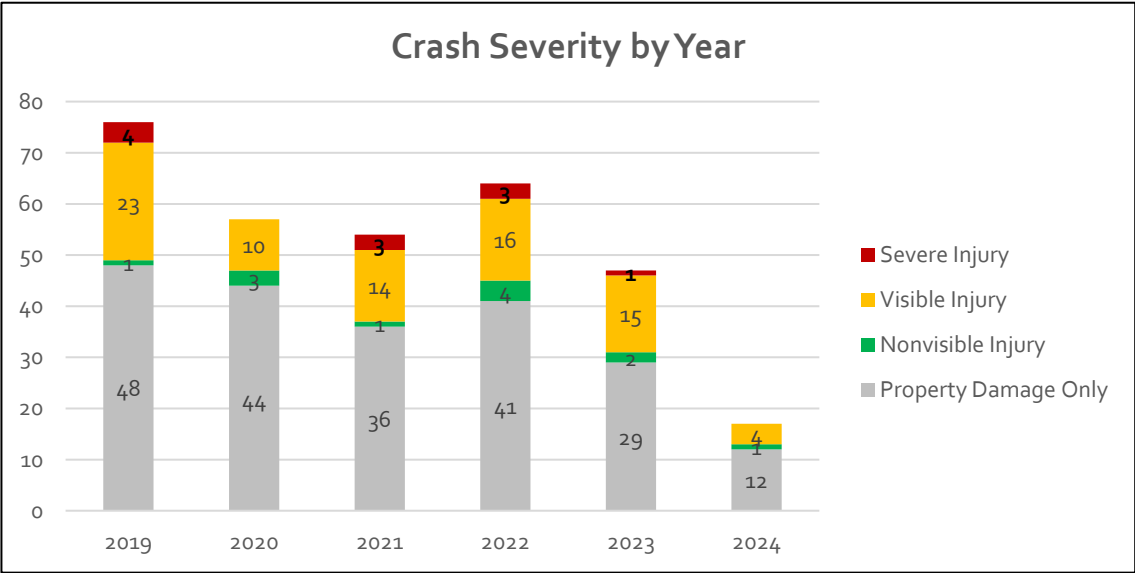
Crash History 2019-2024 – Trends

- There have been zero fatal crashes on this HIN since 2019.
- Angle and sideswipe (same direction) are the most common crash types.
- 2019 saw the highest number of crashes, and overall, crashes have steadily declined. There was a slight increase in 2022, followed by a decrease in 2023.

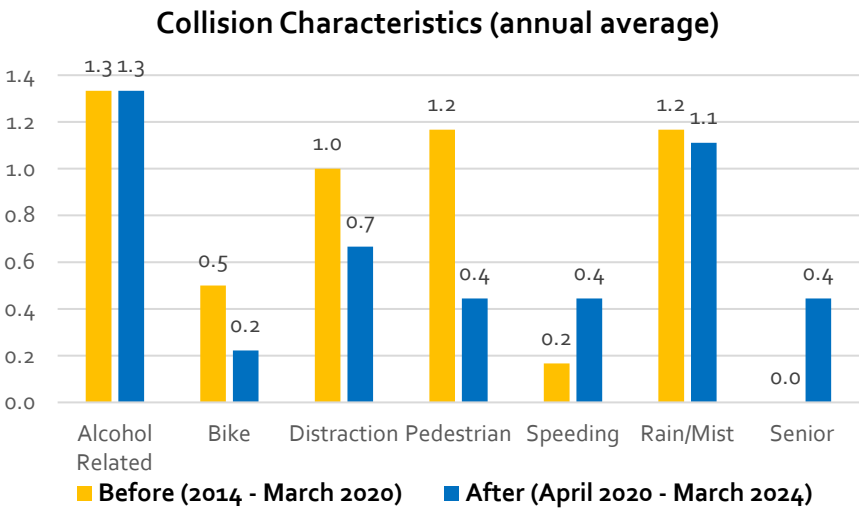
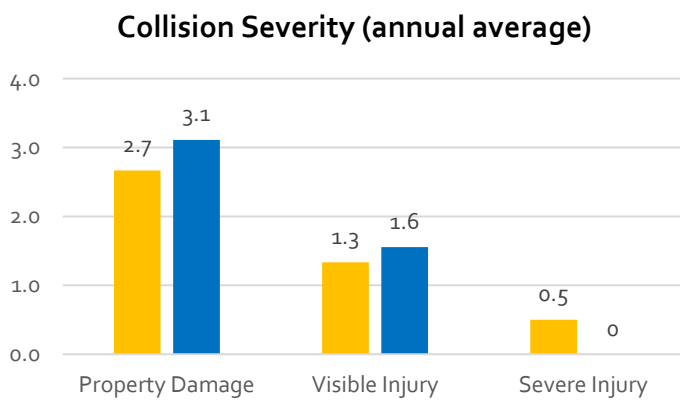
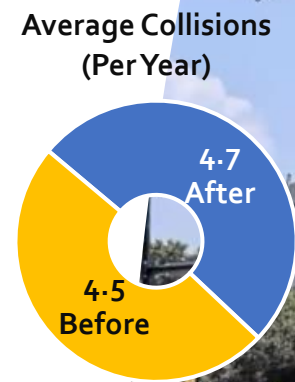
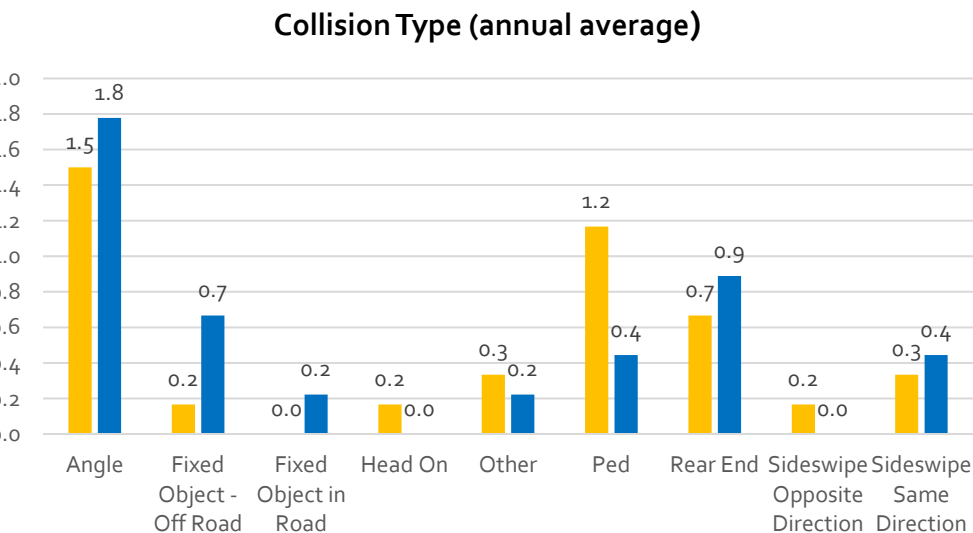
Collisions Before and After: Clarendon Circle

Intersection improvements at [Clarendon Circle](#) were completed in March 2020 as part of the [Clarendon Sector Plan](#) and the [Clarendon Multimodal Transportation Study](#). Improvements include road realignments to reduce intersection size and shorten pedestrian crossing distances, upgrading traffic signals and lighting, closing N Irving St, and adding new curb extensions and bike lanes. **There have been zero severe or fatal crashes, and a decrease in pedestrian and bike crashes after the new updates.**

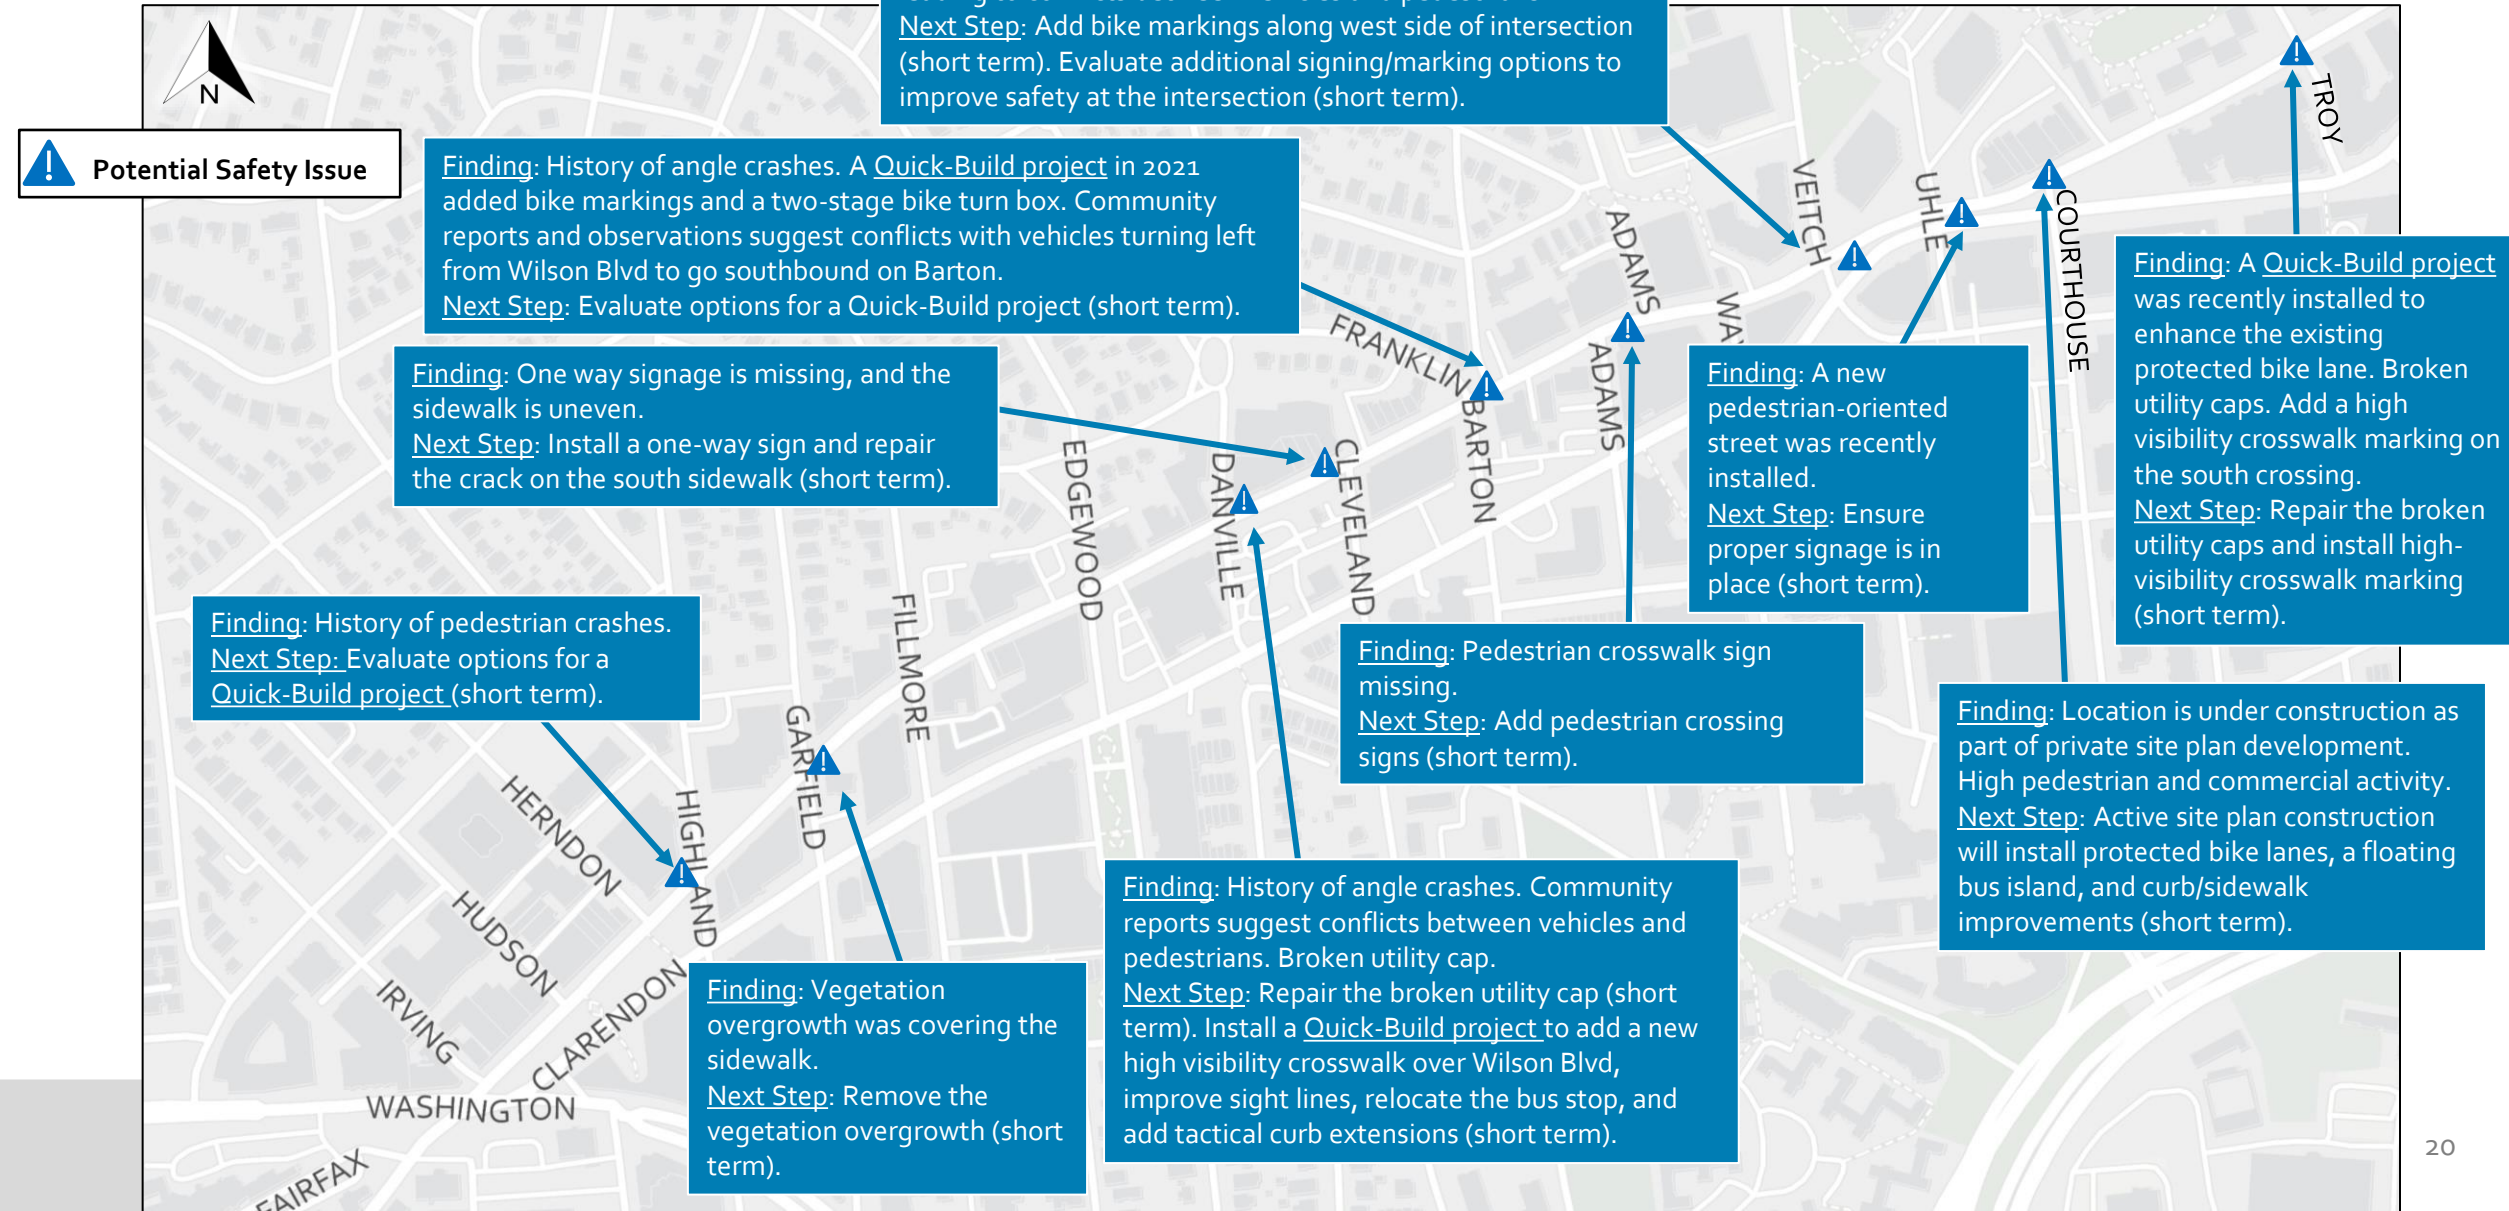
Field Observations: Key Findings & Next Steps

Finding: This intersection was identified as a 2024 Hot Spot location and reviewed during the Washington Blvd HIN safety audit. History of angle, rear end, fixed object, sideswipe, ped, and bike crashes.
Next Step: This intersection was significantly updated during the Clarendon Circle Project. Before/after data indicate fewer bike and pedestrian crashes from the recent intersection rebuild. Evaluate angle and fixed-object crash patterns for additional safety treatments (short term).

Finding: History of angle crashes and fixed-object crashes. Community reports inadequate sidewalks, increase in vehicle volumes, speed, and need for traffic calming measures.
Next Step: The intersection will be upgraded as part of upcoming Wilson Blvd Streetscape Improvements project (short to mid-term).

Finding: This intersection was identified as a 2024 Hot Spot location. History of angle, rear end, pedestrian, sideswipe – same direction, and fixed object crashes. Community reports that the intersection feels unsafe for pedestrians.
Next Step: The upcoming Wilson Blvd Streetscape Improvements project will improve the intersection and upgrade the traffic signal (short to mid-term).

Finding: This intersection was identified as a 2024 Hot Spot location. History of angle, pedestrian, and sideswipe – same direction crashes. Community reports that vehicles turn right on red when pedestrians are present and do not yield. Community reports conflicts between bikes and vehicles on N Quincy St.
Next Step: Assess options to reduce conflicts between pedestrians/bikes and vehicles (short term). Updated parking from 2-hour to 15-minute parking (short term).

Finding: This intersection was reviewed during the N Monroe St HIN safety audit. Issues with the mast arm necessitated the relocation of the signals on a span-wire.
Next Step: Install Accessible Pedestrian Signals (short term). Upgrade the span-wire signal back to a mast arm as part of the maintenance program (long-term).

Finding: History of angle crashes. Community reports that vehicles do not come to a complete stop and block the crosswalk.
Next Step: Assess options for a tactical Quick-Build project to address angle crash history (short term).

Finding: History of angle crashes.
Next Step: Crash patterns were reviewed, revealing that most crashes were caused by alcohol impairment and disregard for traffic signals. The intersection will be monitored for any future crash trends (short term).

- N Highland St – Evaluate options for a Quick-Build project.
 - Clarendon Circle – This intersection was significantly updated during the Clarendon Circle Project. Before/after data indicate fewer bike and pedestrian crashes from the recent intersection rebuild. Evaluate angle and fixed-object crash patterns for additional safety treatments.

- N Monroe St – Install Accessible Pedestrian Signals.
 - N Nelson St – Assess options for a tactical Quick-Build project to address angle crash history.

- N Quincy St – Assess options to reduce conflicts between pedestrians/bikes and vehicles. Updated parking from 2-hour to 15-minute parking.
 - N Randolph St – Crash patterns were reviewed, revealing that most crashes were caused by alcohol impairment and disregard for traffic signals. The intersection will be monitored for any future crash trends.
