N Quincy St Safety Audit

Department of Environmental Services
Transportation Engineering & Operations
15th St N to N Glebe Rd

Audit: September 2025

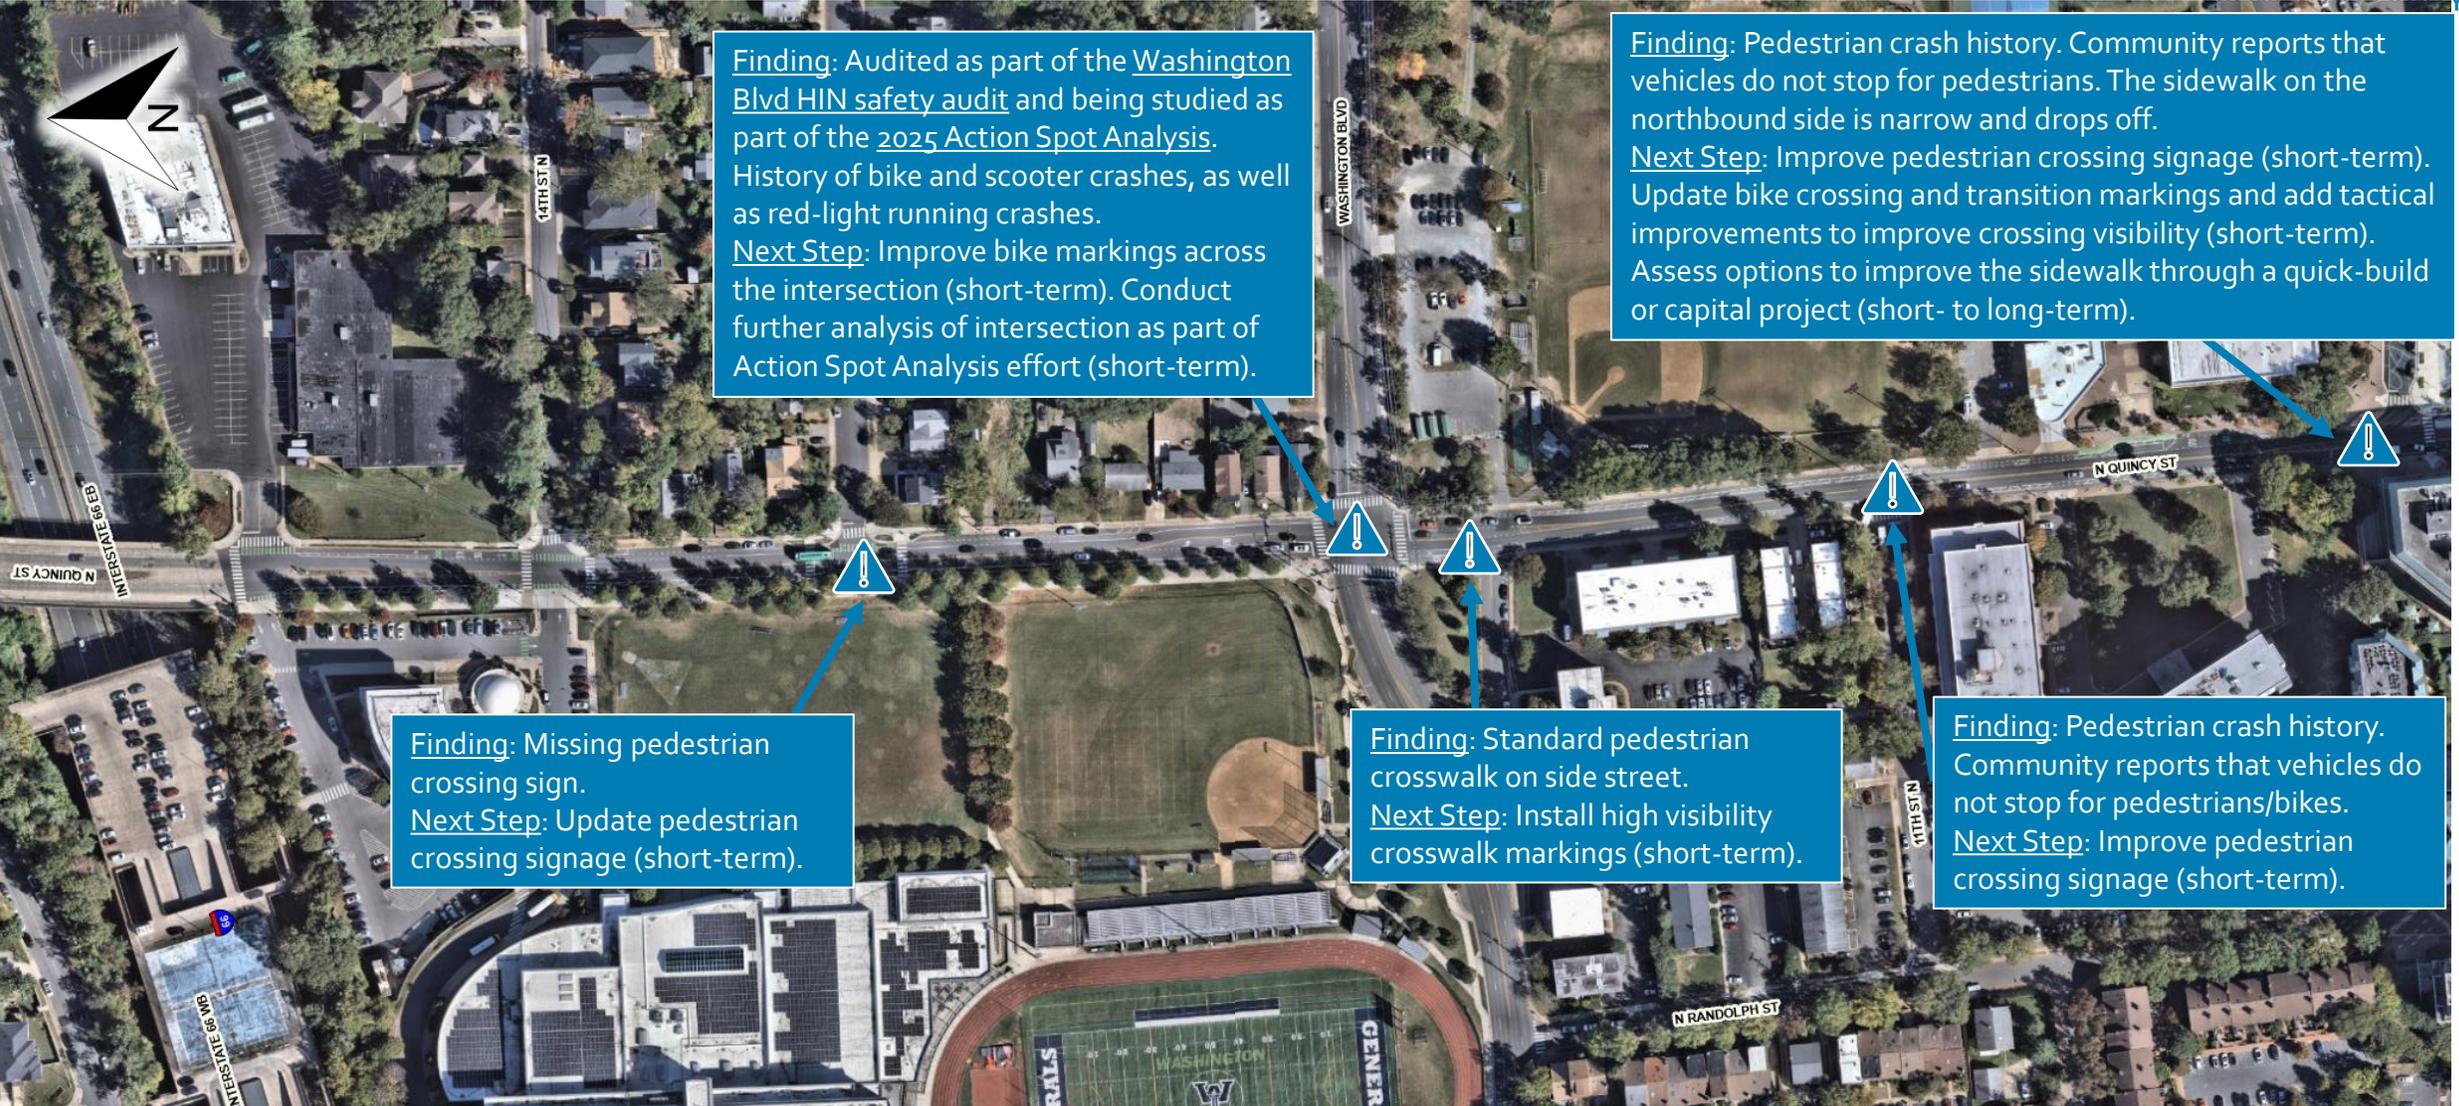
Field Observations: Key Findings & Next Steps

Finding: Audited as part of the Washington Blvd HIN safety audit and being studied as part of the 2025 Action Spot Analysis. History of bike and scooter crashes, as well as red-light running crashes.
Next Step: Improve bike markings across the intersection (short-term). Conduct further analysis of intersection as part of Action Spot Analysis effort (short-term).

Finding: Pedestrian crash history. Community reports that vehicles do not stop for pedestrians. The sidewalk on the northbound side is narrow and drops off.
Next Step: Improve pedestrian crossing signage (short-term). Update bike crossing and transition markings and add tactical improvements to improve crossing visibility (short-term). Assess options to improve the sidewalk through a quick-build or capital project (short- to long-term).

Finding: Missing pedestrian crossing sign.
Next Step: Update pedestrian crossing signage (short-term).

Finding: Standard pedestrian crosswalk on side street.
Next Step: Install high visibility crosswalk markings (short-term).

Finding: Pedestrian crash history. Community reports that vehicles do not stop for pedestrians/bikes.
Next Step: Improve pedestrian crossing signage (short-term).

- **13th St N** – Update pedestrian crossing signage.
- **Washington Blvd** – Improve bike markings across the intersection. Conduct further analysis of intersection as part of Action Spot Analysis effort.

- **South of Washington Blvd** – Install high visibility crosswalk markings.
- **Between Washington Blvd and 11th St N** – Improve pedestrian crossing signage.

- **11th St N** – Improve pedestrian crossing signage. Update bike crossing and transition markings and add tactical improvements to improve crossing visibility.

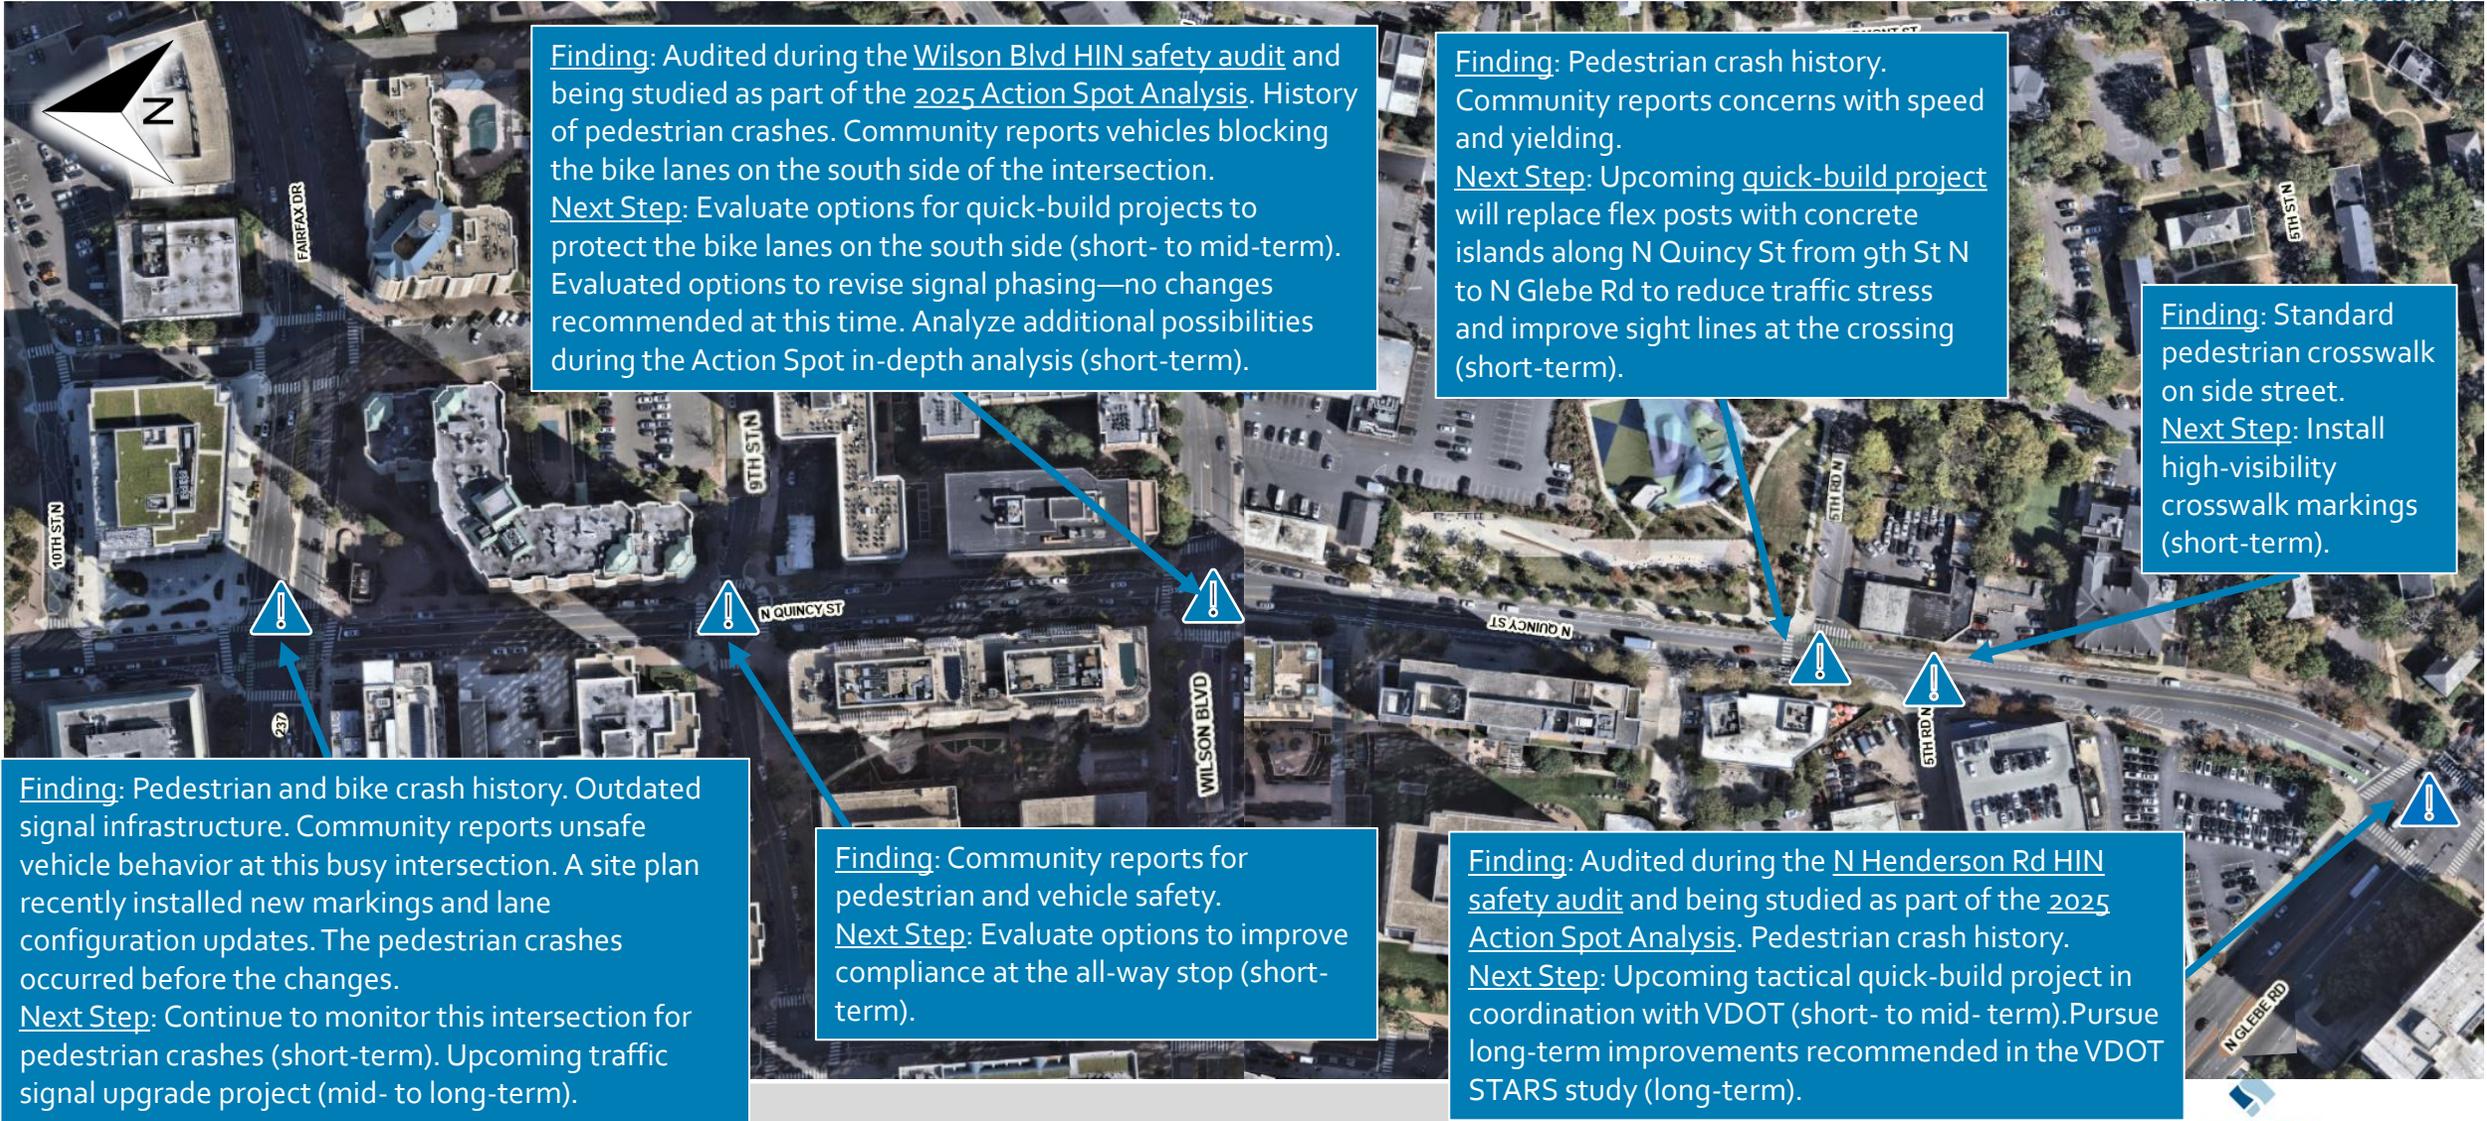
Field Observations: Key Findings & Next Steps

Finding: Audited during the Wilson Blvd HIN safety audit and being studied as part of the 2025 Action Spot Analysis. History of pedestrian crashes. Community reports vehicles blocking the bike lanes on the south side of the intersection.
Next Step: Evaluate options for quick-build projects to protect the bike lanes on the south side (short- to mid-term). Evaluated options to revise signal phasing—no changes recommended at this time. Analyze additional possibilities during the Action Spot in-depth analysis (short-term).

Finding: Pedestrian crash history. Community reports concerns with speed and yielding.
Next Step: Upcoming quick-build project will replace flex posts with concrete islands along N Quincy St from 9th St N to N Glebe Rd to reduce traffic stress and improve sight lines at the crossing (short-term).

Finding: Standard pedestrian crosswalk on side street.
Next Step: Install high-visibility crosswalk markings (short-term).

Finding: Pedestrian and bike crash history. Outdated signal infrastructure. Community reports unsafe vehicle behavior at this busy intersection. A site plan recently installed new markings and lane configuration updates. The pedestrian crashes occurred before the changes.
Next Step: Continue to monitor this intersection for pedestrian crashes (short-term). Upcoming traffic signal upgrade project (mid- to long-term).

Finding: Community reports for pedestrian and vehicle safety.
Next Step: Evaluate options to improve compliance at the all-way stop (short-term).

Finding: Audited during the N Henderson Rd HIN safety audit and being studied as part of the 2025 Action Spot Analysis. Pedestrian crash history.
Next Step: Upcoming tactical quick-build project in coordination with VDOT (short- to mid- term). Pursue long-term improvements recommended in the VDOT STARS study (long-term).

- **Fairfax Dr** – Continue to monitor this intersection for pedestrian crashes.
- **9th St N** – Evaluate options to improve compliance at the all-way stop.

- **Wilson Blvd** – Evaluated options to revise signal phasing—no changes recommended at this time. Analyze additional possibilities during the Action Spot in-depth analysis.

- **5th Rd N (north side)** – Upcoming quick-build project will replace flex posts with concrete islands along N Quincy St from 9th St N to N Glebe Rd to reduce traffic stress and improve sight lines at the crossing.

- **5th Rd N (south side)** – Install high-visibility crosswalk markings.

- **Wilson Blvd** – Evaluate options for quick-build projects to protect the bike lanes on the south side.
- **N Glebe Rd** – Upcoming quick-build project in coordination with VDOT.

- **11th St N** – Assess options to improve the sidewalk through a quick-build or capital project.
- **Fairfax Dr** – Upcoming traffic signal upgrade project.
- **N Glebe Rd** – Pursue improvements recommended in the VDOT STARS study.

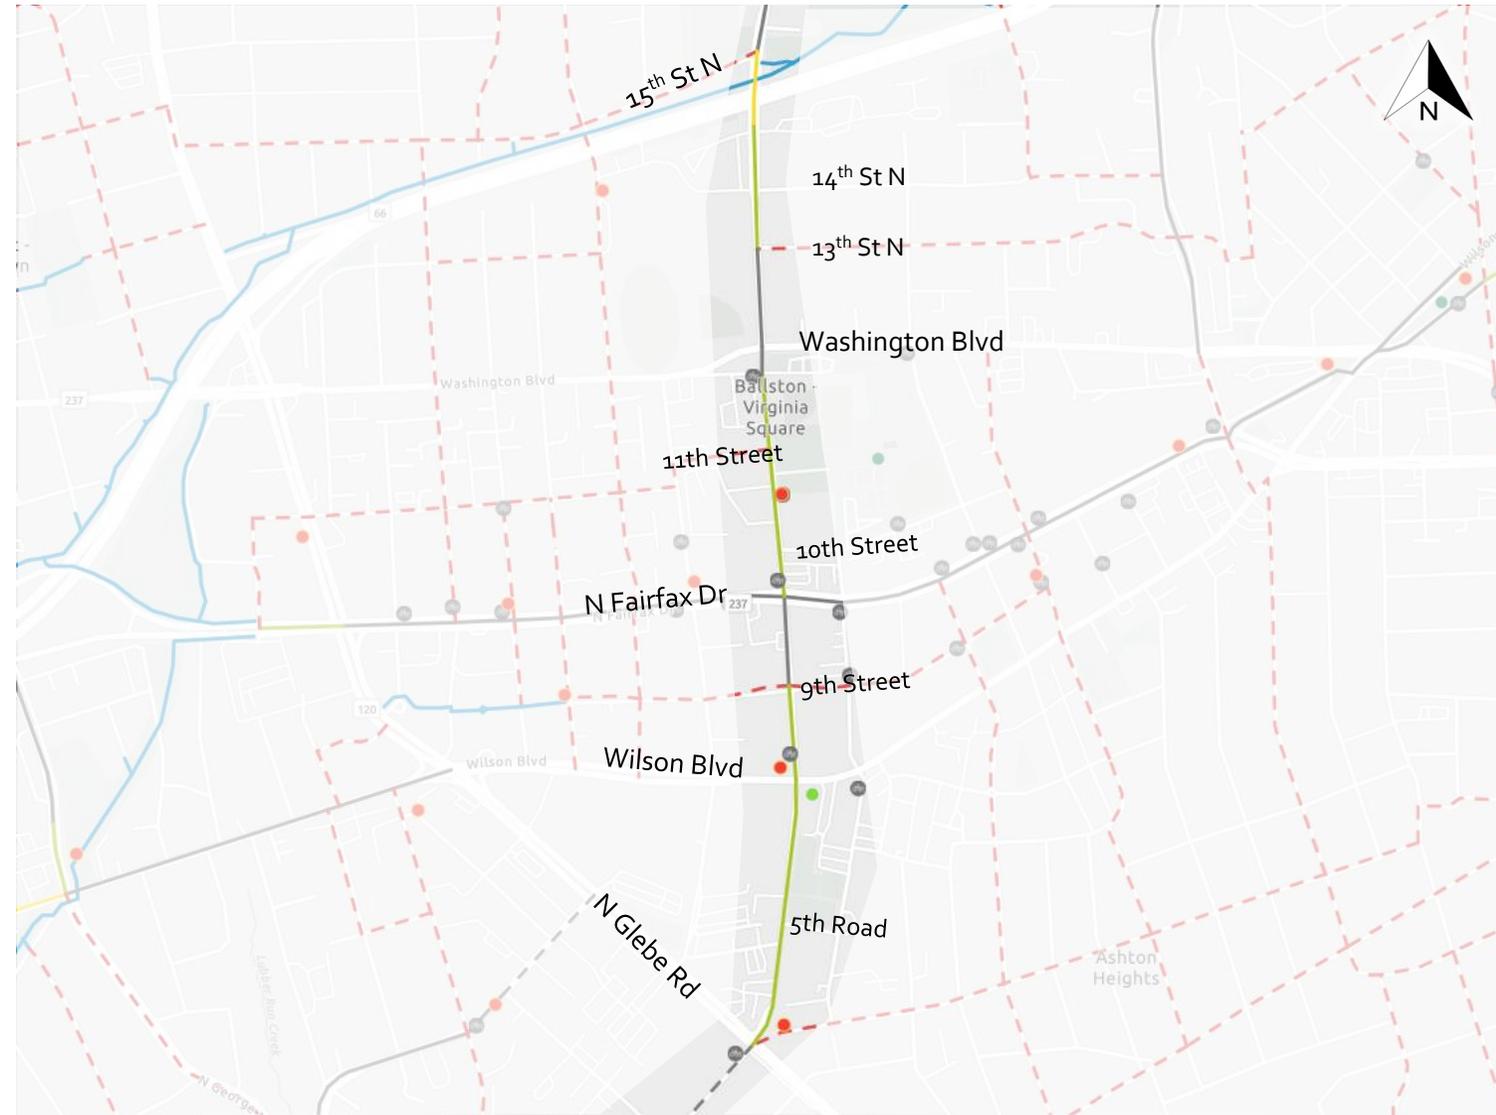
N Quincy St has bike lanes, which are mostly protected through along the HIN segments and provides a critical north-south bike connection in Arlington.

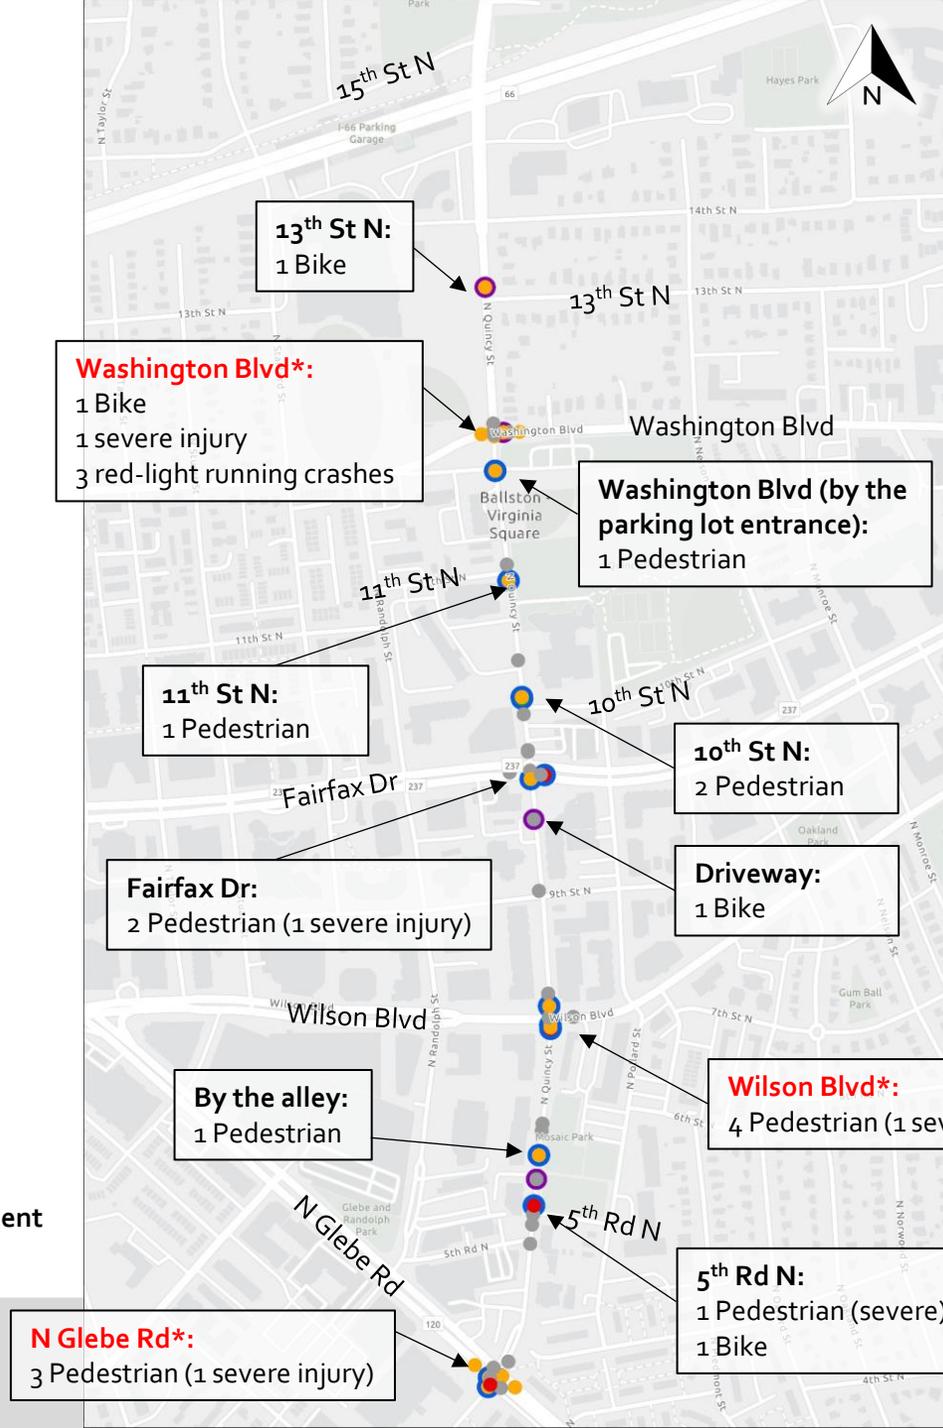
Crash History (2022-2025)

- The most common type of crashes were angle crashes followed by pedestrian crashes.
- Four out of the five severe crashes along this corridor involved a pedestrian. Out of those four, one person was riding a scooter. The non-pedestrian severe crash was an angle collision between a vehicle and a person on an e-bike.

Specific crash type patterns are called out in the text boxes where present
*Identified Vision Zero [Crash Action Spot](#) in 2025

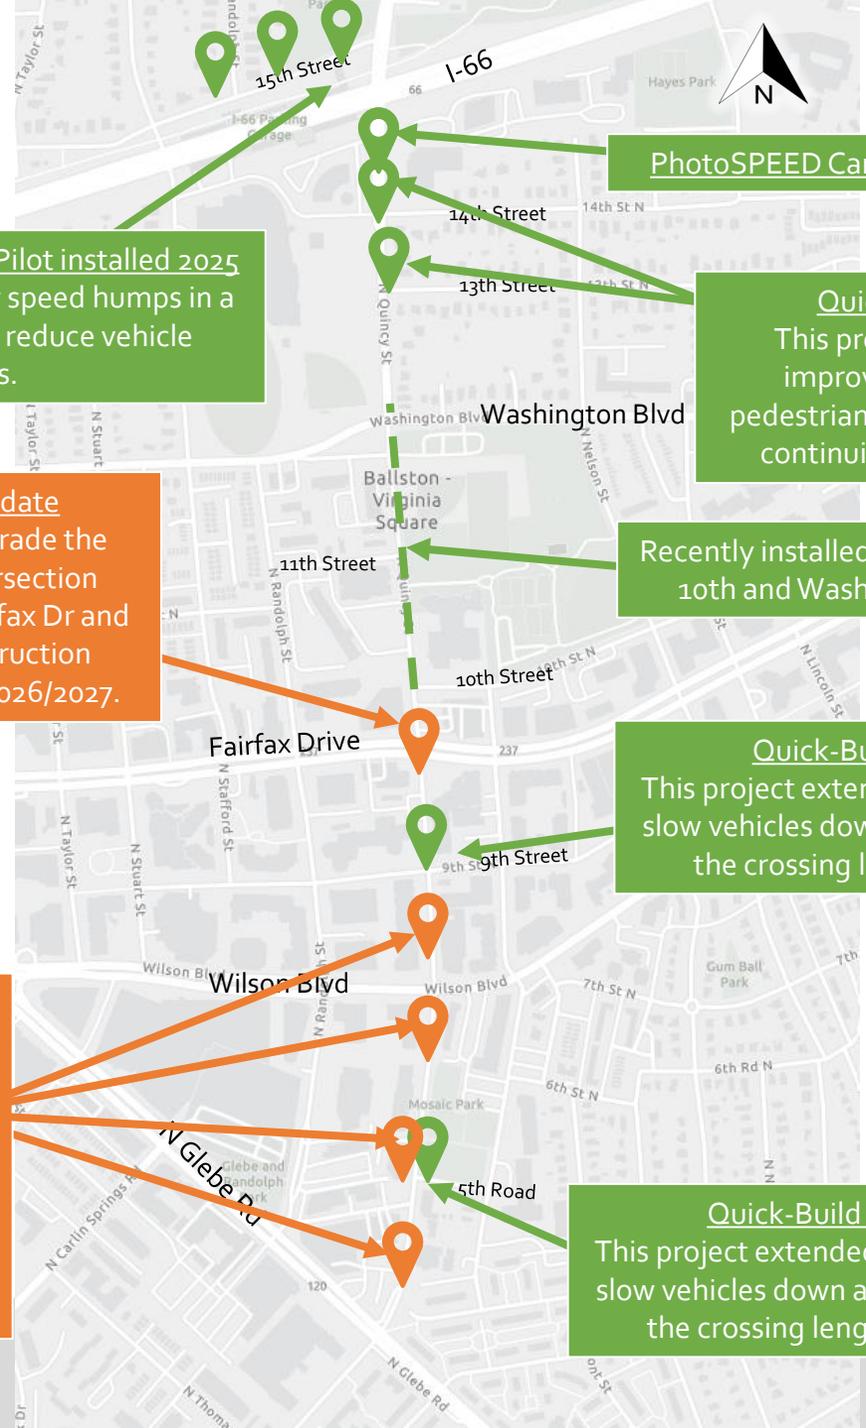
Recent and Upcoming Projects & Developments

Tactical Speed Humps Pilot installed 2025
This pilot installed new speed humps in a school slow zone to reduce vehicle speeds.

Traffic Signal Update
This project will upgrade the signal and add intersection improvements at Fairfax Dr and N Quincy St. Construction anticipated to start 2026/2027.

Quick-Build Project
This project will replace existing flex posts with permanent concrete islands along N Quincy St from 9th St N to N Glebe Rd to reduce traffic stress, prevent vehicles from blocking the bike lanes, and improve sight lines/sight distances.

Quick-Build Project (2024)
This project installed multimodal improvements which enhanced pedestrian safety crossings and allowed continuity of the existing bike lane.

Recently installed curb stops between 10th and Washington Blvd. 2025

Quick-Build Project (2024)
This project extended the northeast curb to slow vehicles down as they turn and reduce the crossing length for pedestrians.

Quick-Build Project (2021)
This project extended the northeast curb to slow vehicles down as they turn and reduce the crossing length for pedestrians.
