# S Glebe Rd Safety Audit

Department of Environmental Services  
Transportation Engineering & Operations  
**Columbia Pike to 24<sup>th</sup> Rd S**

Audited: February 2026  
Published: June 2026

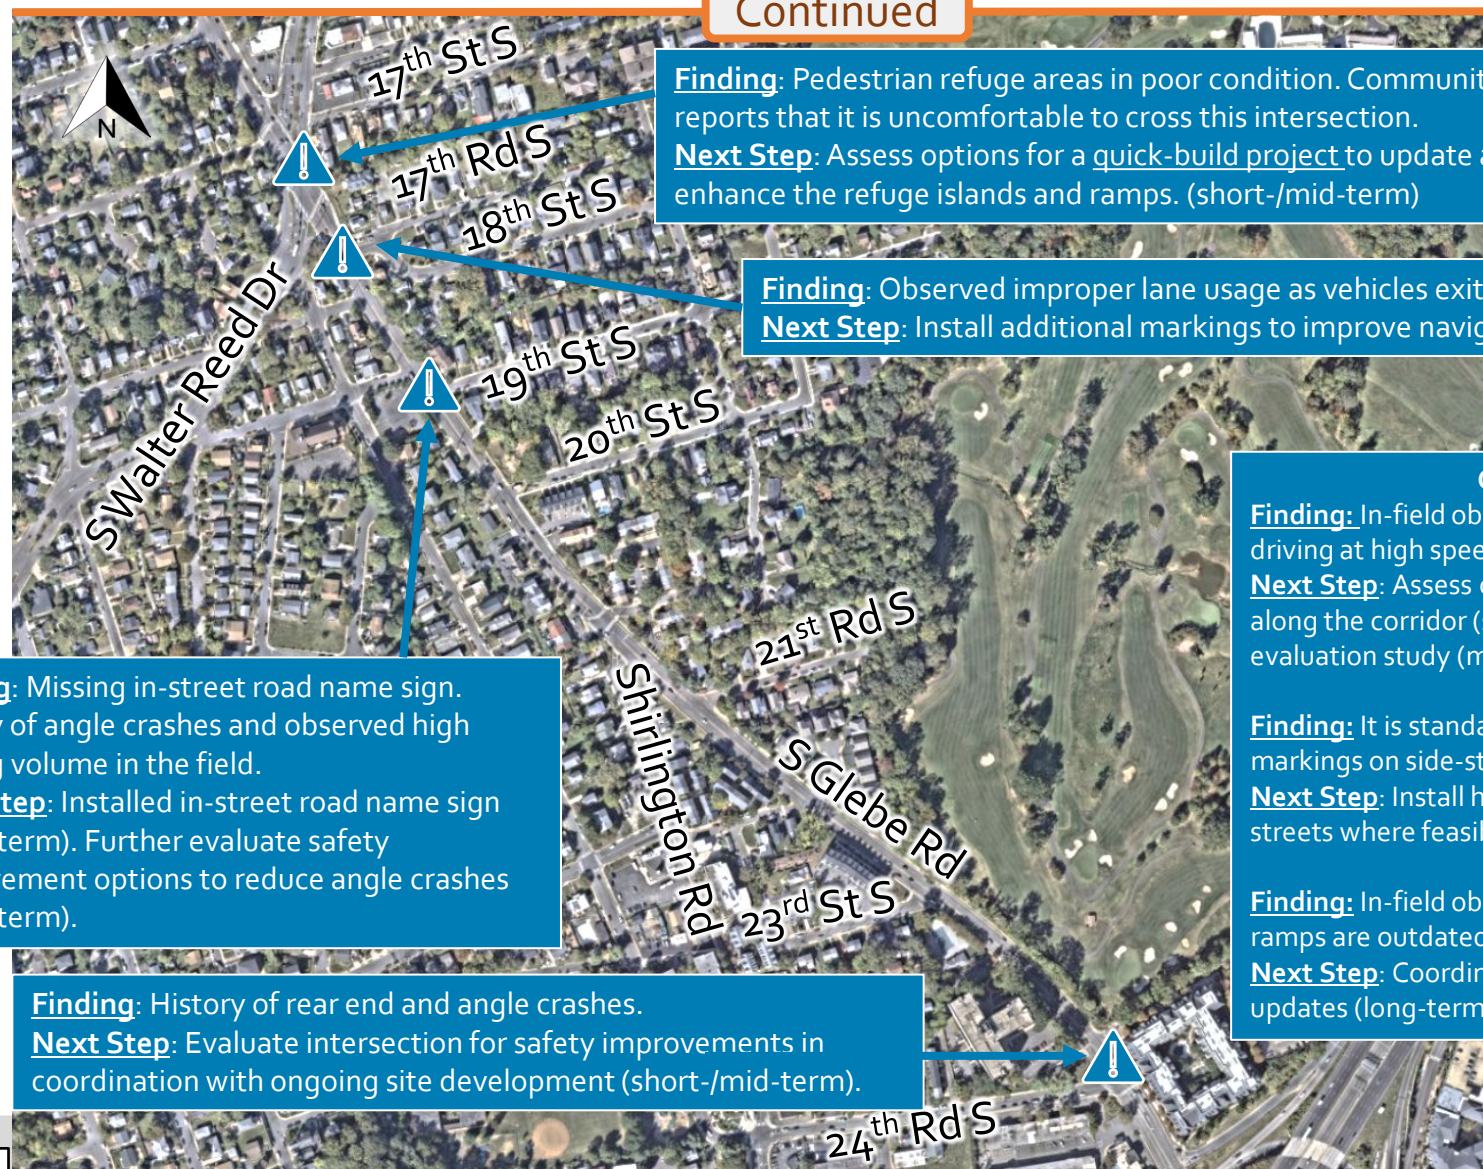
# Field Observations: Key Findings & Next Steps

**Finding:** Pedestrian refuge areas in poor condition. Community reports that it is uncomfortable to cross this intersection.  
**Next Step:** Assess options for a quick-build project to update and enhance the refuge islands and ramps. (short-/mid-term)

**Finding:** Observed improper lane usage as vehicles exited/entered 17<sup>th</sup> Rd S.  
**Next Step:** Install additional markings to improve navigation (short-term).

**Finding:** Missing in-street road name sign. History of angle crashes and observed high turning volume in the field.  
**Next Step:** Installed in-street road name sign (short-term). Further evaluate safety improvement options to reduce angle crashes (short-term).

**Finding:** History of rear end and angle crashes.  
**Next Step:** Evaluate intersection for safety improvements in coordination with ongoing site development (short-/mid-term).
