# GULF BRANCH OUTFALL REPAIR

N Nelson St Outfall  
Fall 2025 Engagement

# Outfall Area Current Conditions, Goals & Considerations

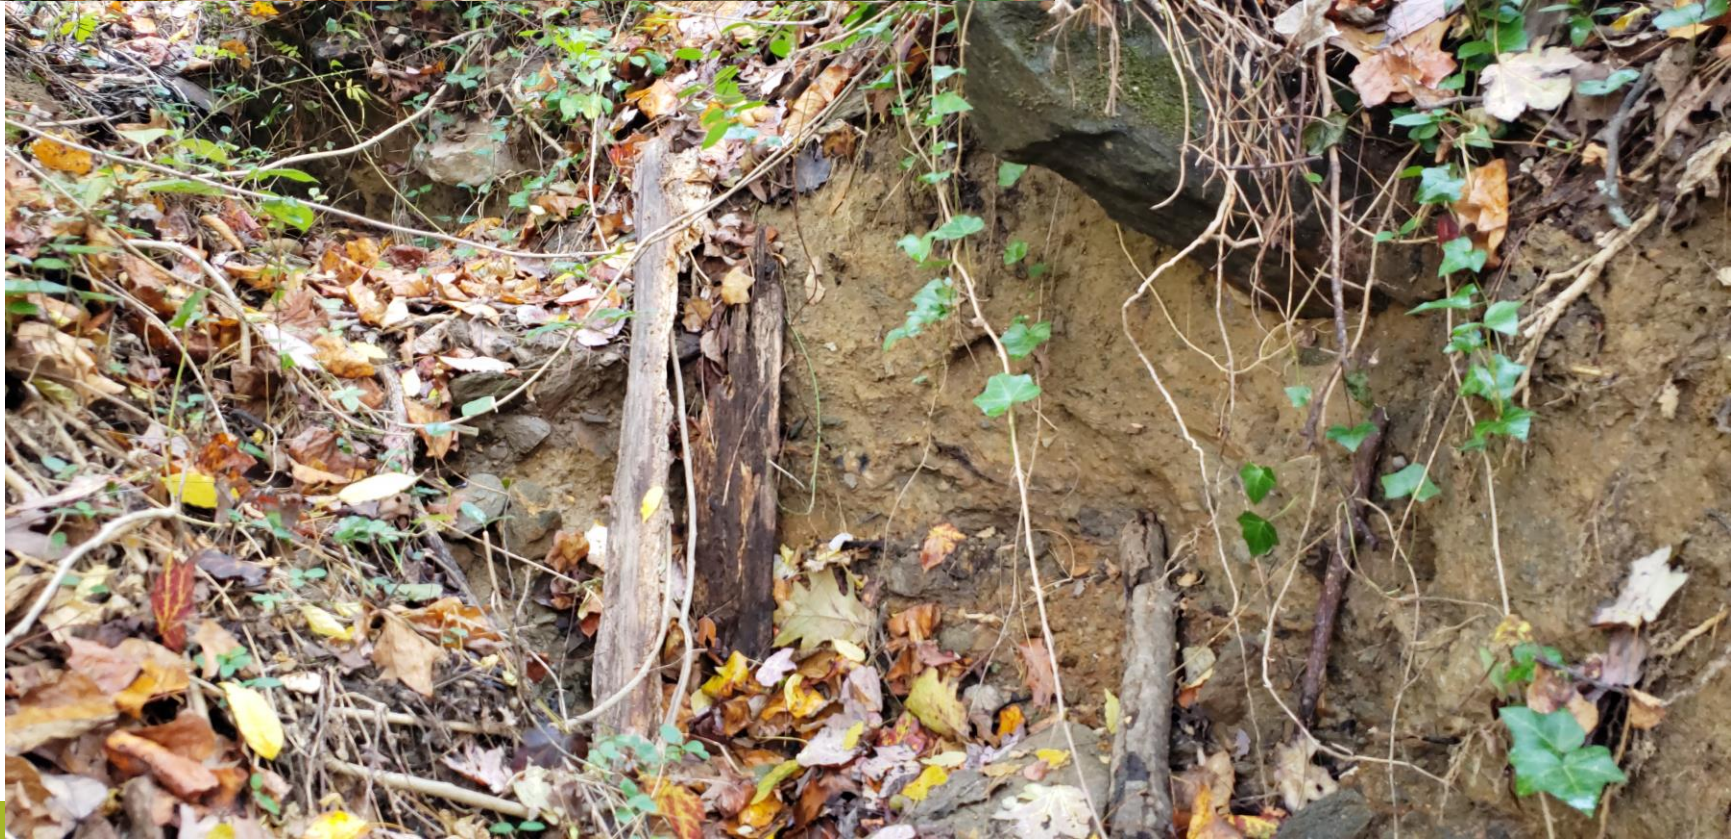
- Actively eroding, damaged outfall
- Broken corrugated metal storm pipe
- Active erosion adjacent to storm pipe
- Concrete pad undermined, Water drips through hole
- Invasive English Ivy and Porcelainberry

- Create a stable outfall
- Maintain the storm infrastructure, repair erosion
- Remove invasive plants, add native plants
- Minimize impacts to the stream corridor
