# Proposed Redesign of Nelly Custis Park

AURORA HIGHLANDS CIVIC ASSOCIATION

NEIGHBORHOOD CONSERVATION PROGRAM

NOVEMBER 8, 2017

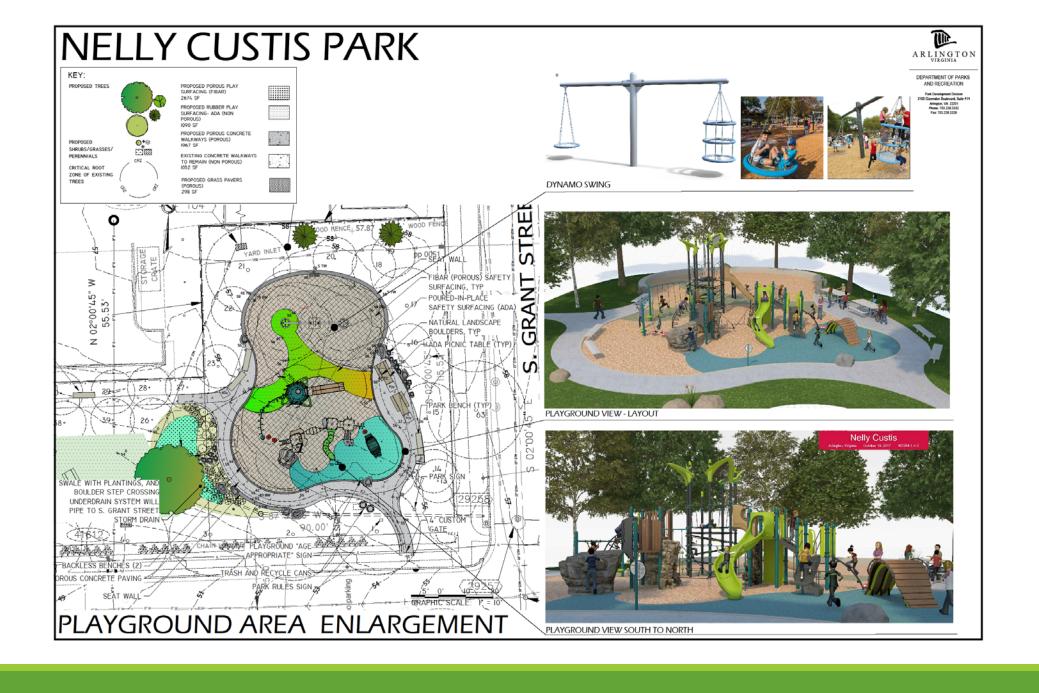
### Play Area Renovation

- New playground in area of existing playground
- Play area subsurface treated as a stormwater management facility
- oVegetated swale, seat walls and boulders, serves as separation between the playground/west side of the park. Large oak tree to be planted on west side of swale for shade

New play equipment meets ADA compliance and playground safety standards

More efficient layout increases useable play area close to 40%

Stormwater management underneath the playground area decreases runoff to 24th Street South

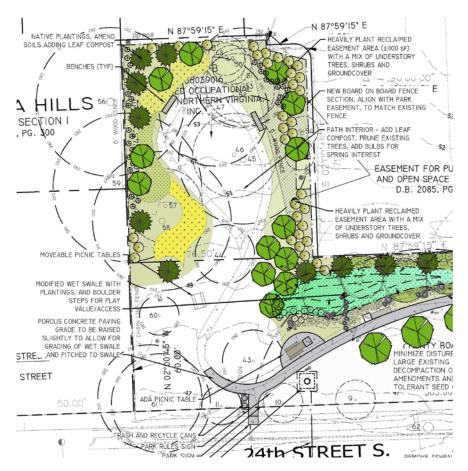
## Contemplative Area Design Details

Re-incorporates 1100 sf of parkland outside of existing board fence

Creates a "contemplative" area planted with mix of native trees, shrubs and perennials.

Includes two years of establishment with watering and mulching.

Benches, moveable picnic tables and plantings to allow for small gatherings away from the hustle and bustle of the playground

Increased size by of easement re-aligning fence with the easement border along the Linden parking lot. Wooden fence section going north/south will be replaced by similar board fence

Concrete path loop will be retained

Plantings, including a mix of deciduous and evergreen trees, shrubs and perennials will be planted in the easement and along the fence borders
