# N Randolph St and 20<sup>th</sup> Rd N

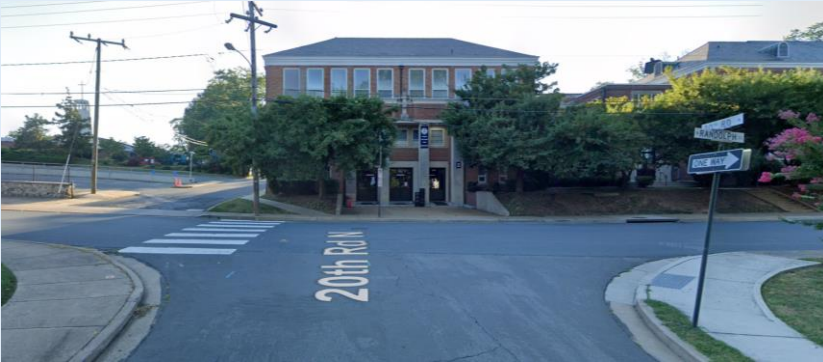
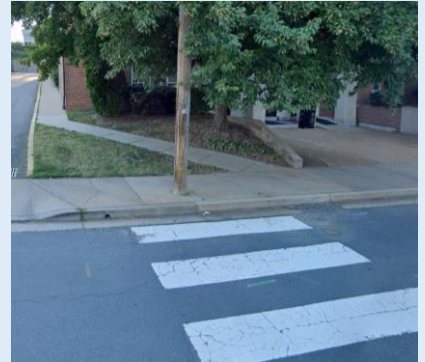
## BEFORE TREATMENT

**Safety Issue:** The crosswalk leading to St. Agnes School was not marked or ADA accessible. Previously, there was a crosswalk on N Randolph St that led directly to a utility pole and did not have a curb ramp.

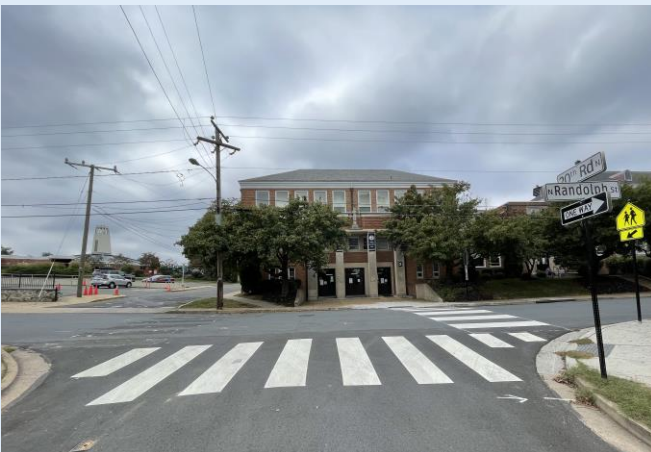
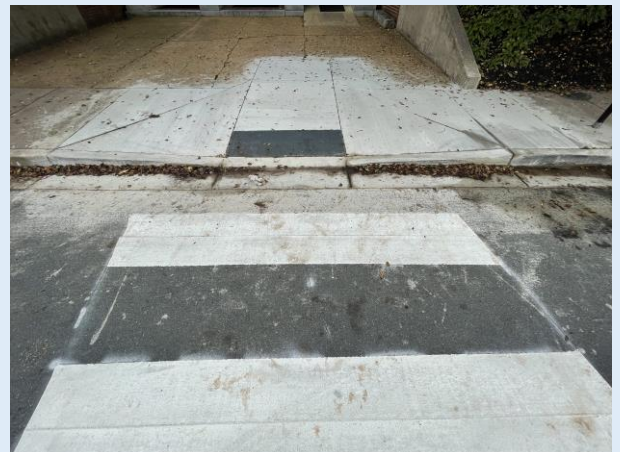
## AFTER TREATMENT

**Project Description:** This project improved accessibility by moving the crosswalk a few feet north to a location without any obstructions, installing a new curb ramp, and marking two new high visibility crosswalks. In addition, a school crossing sign was installed to increase visibility of pedestrians, especially children, crossing at this location.
