HISTORICAL AFFAIRS AND LANDMARK REVIEW BOARD
ARLINGTON COUNTY, VIRGINIA

CERTIFICATE OF APPROPRIATENESS STAFF REPORT

TO: Historical Affairs and Landmark Review Board (HALRB)
FROM: Lorin Farris, Historic Preservation Planner
DATE: February 9, 2023
SUBJECT: CoA 23-03, Columbia Pike Form Based Code, 2910 Columbia Pike, Historic Facade

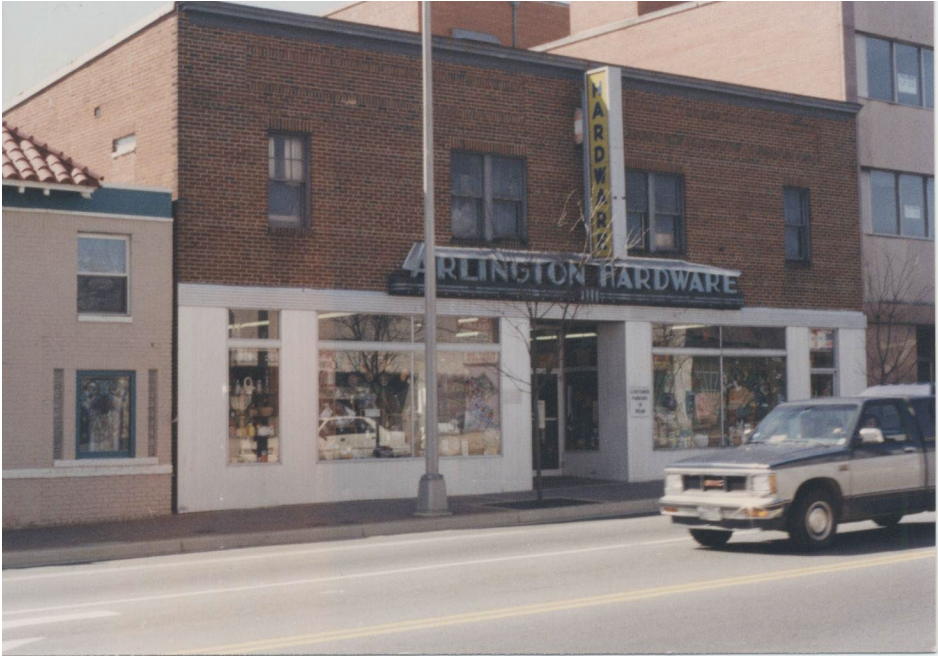
Figure 1: Photograph of the Arlington Hardware Building prior to the electrical fire in 1996 (Arlington County HPP)

The HPP staff does not recommend approval of the subject application as submitted. The HPP staff located two historic photographs depicting the Arlington Hardware Building prior to the electrical fire in 1996, and after its renovation when it reopened as a gift and garden shop, which was operated by David Eisen's daughter, Leonora Gabaldon, from 1996 until its closing in 2004 (Figures 1 and 2). Both photographs show the first story containing the existing window fenestration pattern, which remain 7' by 13' large plate glass windows topped by transoms. The material behind the vertical metal paneling at the first story could not be determined from historic photographs.

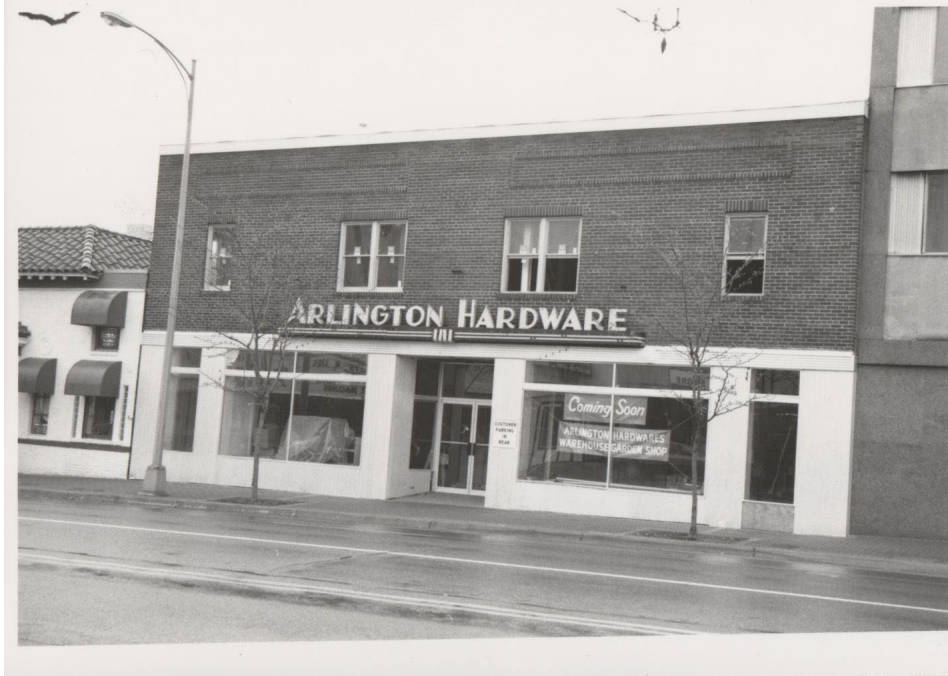
Figure 2: Photograph of the Arlington Hardware Building in April 1997 (Arlington County HPP)
