Little Falls Rd – John Marshall Dr to N Kensington St

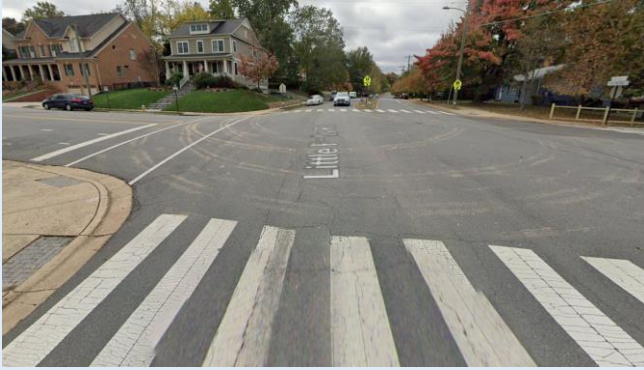
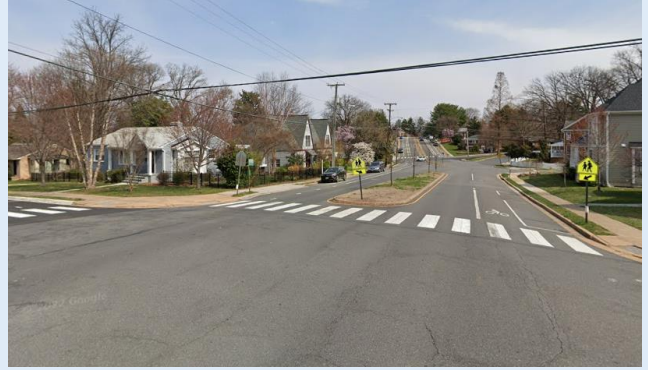
BEFORE TREATMENT – At John Marshall Dr & Little Falls Rd Intersection

Safety Issue: Project identified through critical crash response in 2022.

Project Description: (1) Improvements at John Marshall Dr include addition of a high visibility crosswalk on the south crosswalk, tactical curb extensions to sharpen/slow down turning vehicle turns and reduce crossing distances, and additional signage.

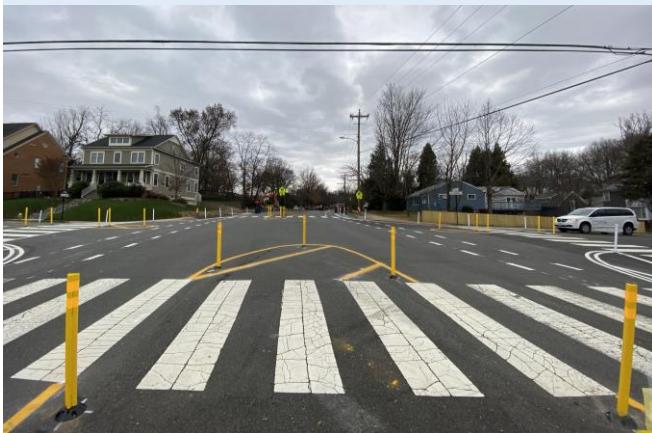
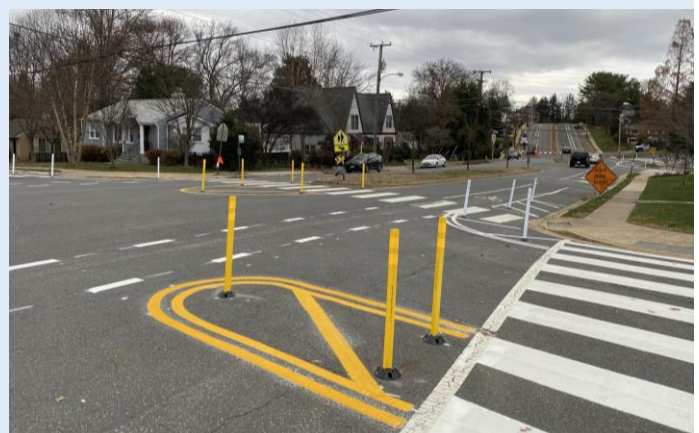
AFTER TREATMENT – At John Marshall Dr & Little Falls Rd Intersection
