Collisions Before and After: Westbound Langston Blvd & N Lynn St

This intersection was identified as a Vision Zero Hot Spot in 2019. In a joint effort between Arlington and the Virginia Department of Transportation (VDOT), [the Lynn Street Esplanade and Custis Trail Improvements project](#) was a pedestrian and bicycle safety, traffic management and street beautification initiative in Rosslyn. The Lynn Street Esplanade, completed in May 2020 provides widened sidewalks, intersection improvements, upgraded traffic signals, on street bike lanes, and improved street lighting and signage. **The average number of collisions per year decreased from 7.5 in 2014-2020 (before the project) to 4 in 2020-2022 (after the project).**

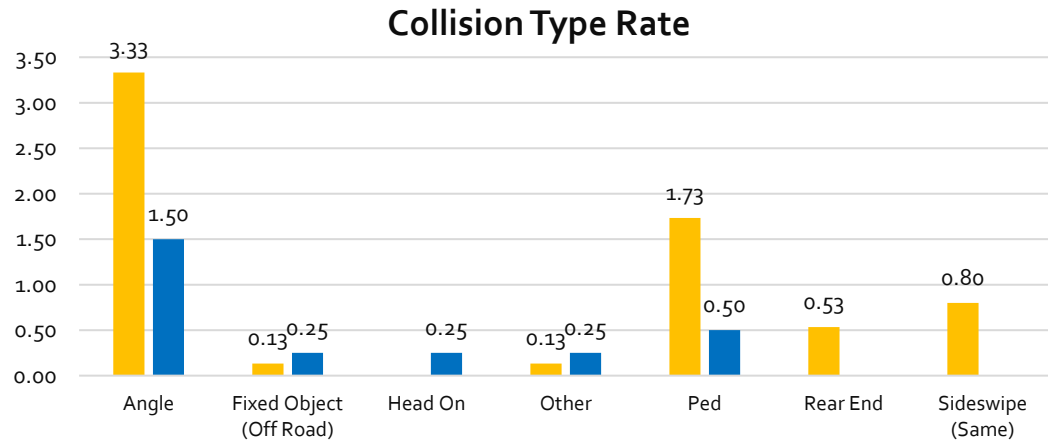
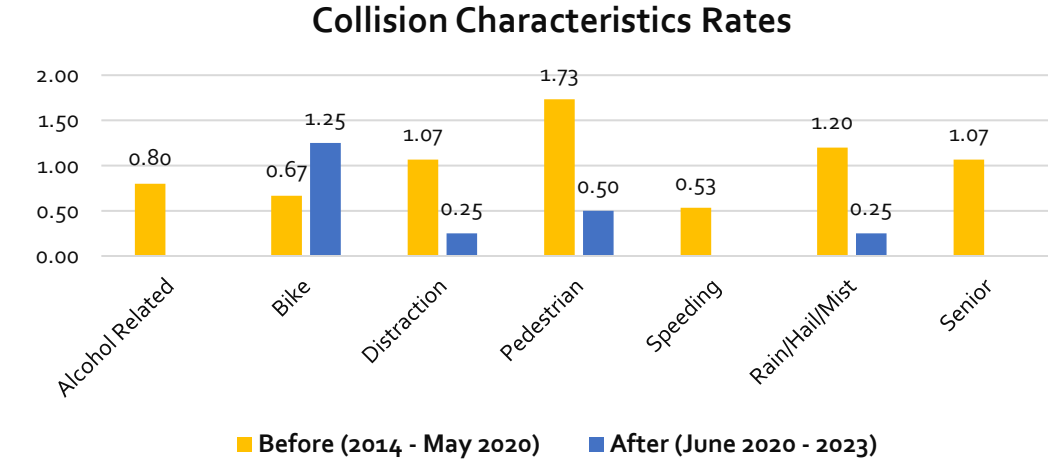
Key Findings:
 Overall fewer crashes and fewer injuries;
 Slightly higher bike crash rate
Next Step:
 Evaluate feasibility of additional signal phasing options to address trail crossing safety
